*Accessibility Evaluation
for*

**City of Healdsburg, CA
Community Services and
Parks & Recreation Department**

2017

julee quarve-peterson, inc.

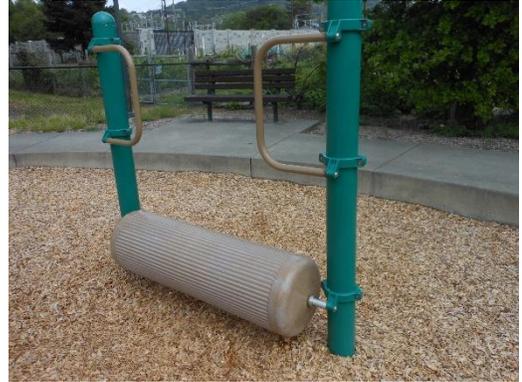
Ground Level Events

Based on the number of elevated play components (events) a minimum number of ground level play components are required. Currently only 5 ground level components are provided- log roll, chin-up bar and 3 play panels on the 2-5 year old composite. A minimum of 8 ground level events are required.

Priority 3- Add ground level play components (of a variety of different types) within the defined play area. *ADA Table 240.2.1.2*

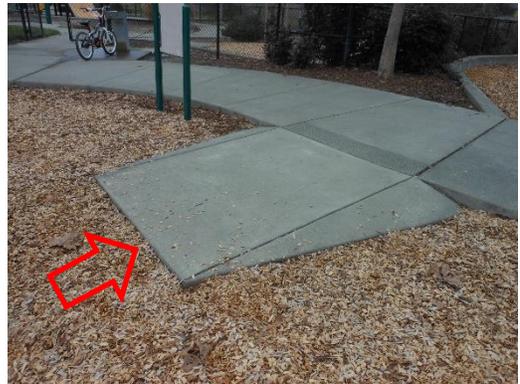
A concrete ramp creates an accessible route into the loose fill surface material of the defined play area at the to-fro strap swings. There is currently a 3" vertical drop between the end of the concrete ramp and the surface material.

Maintenance- Add loose fill surface material (or redistribute existing material) to reduce the vertical change to ¼" maximum. *ADA 303.2*

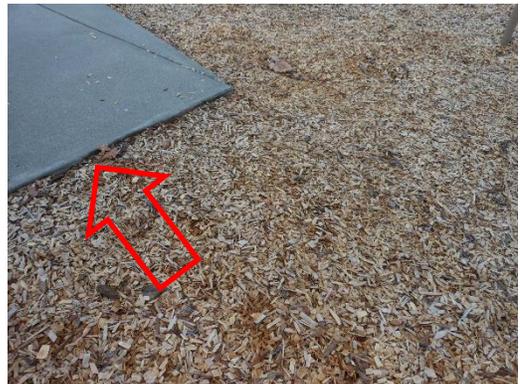
Area D

A concrete ramp creates an accessible route into the loose fill surface material of the defined play area at the to-fro bucket swings. There is currently a 1" vertical drop between the end of the concrete ramp and the surface material.

Maintenance- Add loose fill surface material (or redistribute existing material) to reduce the vertical change to ¼" maximum. *ADA 303.2*

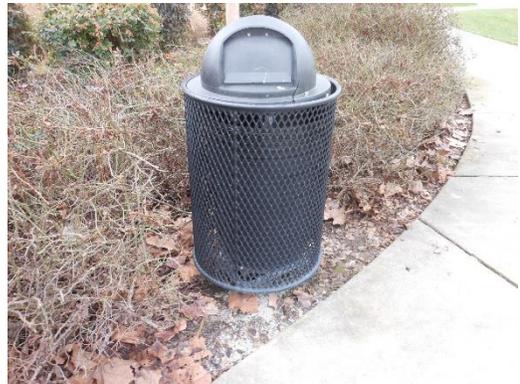
Trash receptacles are located throughout the park. They are typically located adjacent to the accessible route. *This is a good example of accessibility.*

Maintenance- Ensure that when trash is emptied/collected, the lid is positioned facing the accessible route so the opening is located within reach range. *ADA 308*

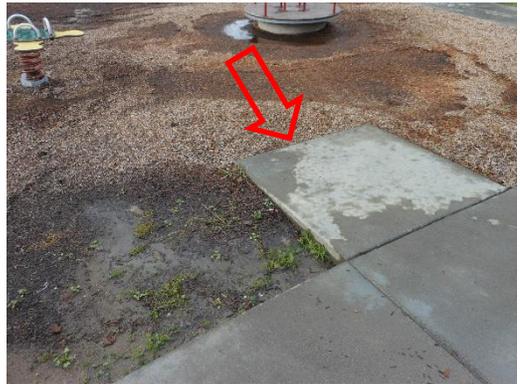
Area D

A concrete ramp creates an accessible route into the loose fill surface material of the defined play area. There is currently a 1" vertical drop between the end of the concrete ramp and the surface material. Much of the loose fill surface material had been washed away at the time of site visit.

Maintenance- Add loose fill surface material (or redistribute existing material) to reduce the vertical change to ¼" maximum. *ADA 303.2*

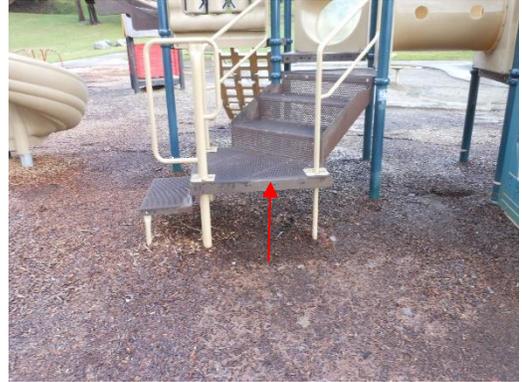
A transfer platform is provided at the composite structure to provide access to the elevated events.

The transfer platform is currently 21" above the surface of the loose fill material (vs. 11"-18").

Maintenance- Add loose fill surface material (or redistribute existing material) to reduce the height of the transfer platform to 11"-18". *ADA 1008.3.1.2*

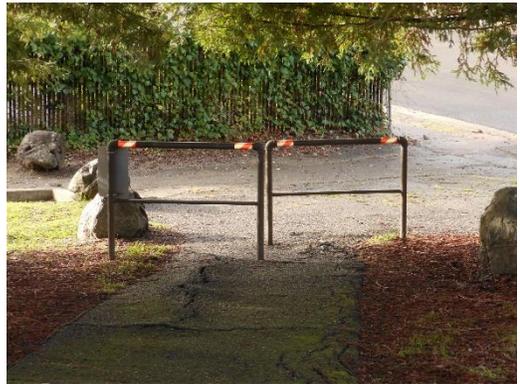
Northwest

The route to the NW corner of the park (Parkview Drive) is currently in rough condition; the slope of the route is currently as steep as 16.5% (vs. 5% maximum).

Priority 1- Include information on the city's website and brochures indicating the location of the accessible route. *ADA 216.6*

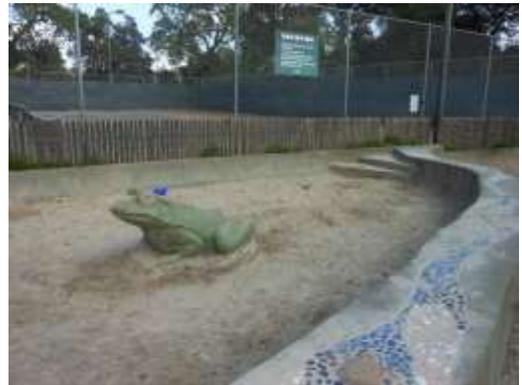
There is not currently an accessible route into the sand play area (bordered by the water play even)- there are 3 steps at the south end. There are 2 climbing sculptures located within the sand play area. Climbing sculptures are also provided in the loose fill wood surface material. *This is a good example of accessibility.*

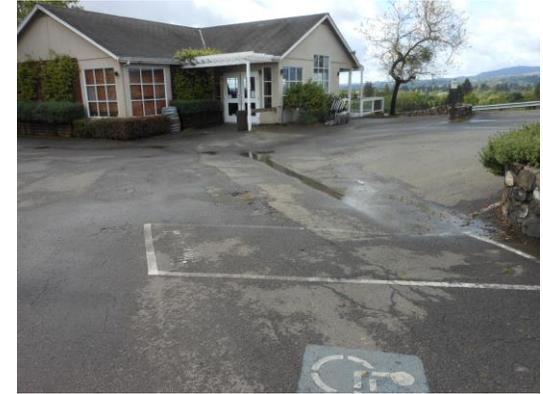
Photo 3: The route from the accessible parking spaces to the clubhouse entry requires crossing the driving lane. There is currently up to 5.8% slope (vs. 5% maximum) and the surface is rough and deteriorating.

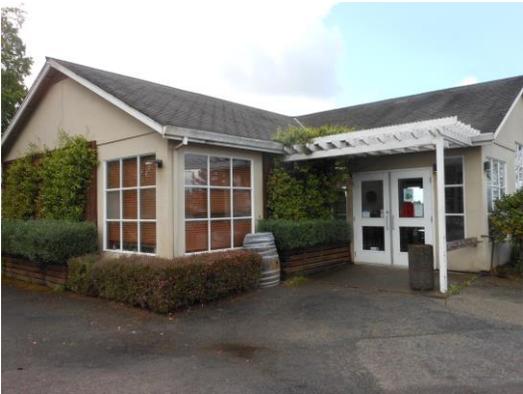
Photo 4: There is currently up to 4.1% slope within the maneuvering clearance for the main entry (vs. 2% maximum).

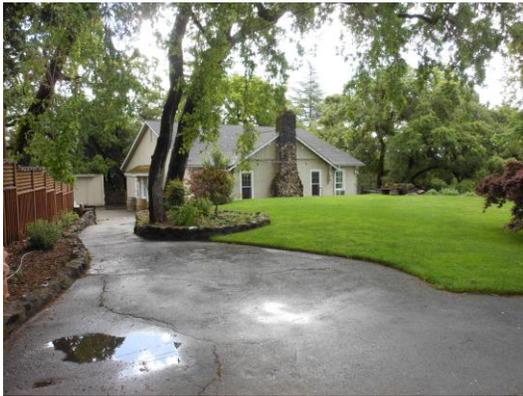
Photo 1: View of route from the clubhouse to the rental building. There is damage along the route from tree roots that creates rises greater than 1/4".

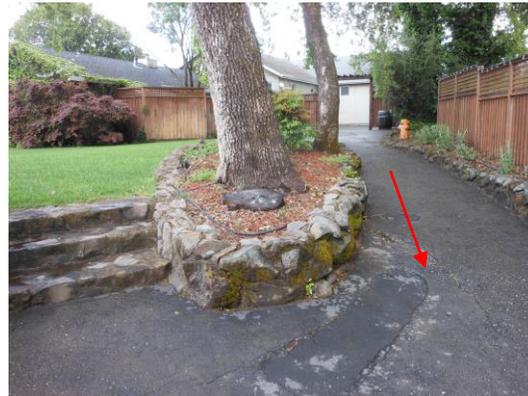
Photo 2: The exterior route to the rental building is currently as steep as 11%.
