**A REVISED CULTURAL RESOURCES  
EVALUATION OF  
120 PARKLANDS BLVD.,  
HEALDSBURG, SONOMA COUNTY,  
CALIFORNIA  
(APN 091-040-111 AND 114)**

**SUBMITTED BY  
William Roop, ARCHAEOLOGICAL RESOURCE SERVICE**

**September 5, 2016**

**A.R.S. Project 16-005**

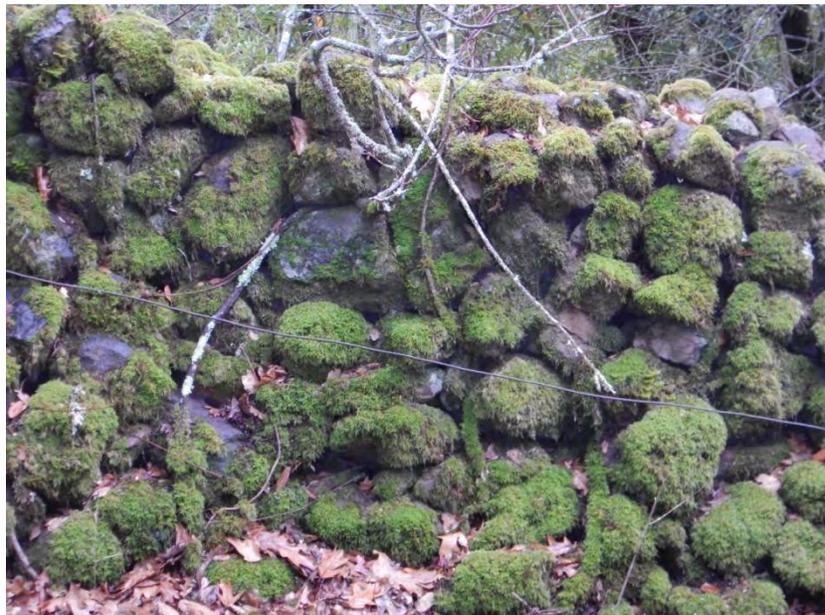
**FIGURE 9 -- PART OF THE ROCK WALL (CA-SON-1765H)**

The fallen rocks in the foreground indicate that some deterioration has occurred, but the wall generally is in very good shape.

CA-SON-1765H is a rock wall alignment consisting of four stacked field-stone features, including three rock alignment sections and one pile of field-stone. The longest section of rock alignment, Feature 1, measures approximately 1230 feet long and 2 feet wide located parallel to and approximately 10 feet north of a gravel access road. Another section of alignment, Feature 2, measures approximately 500 feet long. The smallest length of rock alignment measures 230 feet long. Also noted at the east end of Feature 3 was a pile of rock, probably abandoned building material for construction of the wall. Although portions of the wall have collapsed, the site's integrity appears good (Bramlette and Benson 1989:7-8).

It is recommended that the stacked stone wall be preserved in place. The wall should be protected during the development phase of the project by placing exclusion fencing between the wall and any active excavation, grading, trenching, or other construction work. If any work is undertaken that will involve intense vibration, such as a vibrating compacting machine, the wall segments close enough to the equipment to be impacted by the vibration should be protected from damage by placing bracing along both sides of the wall. This is particularly necessary in any location where the wall is more than three rocks high. As shown on the development plan, an emergency access will be developed at parcel 9

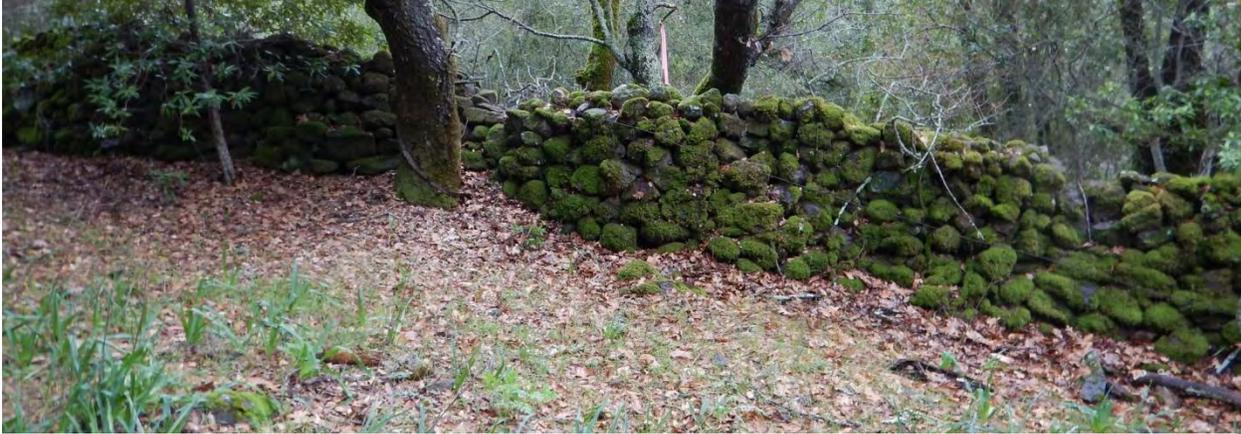
**FIGURE 10 -- ANOTHER VIEW OF THE ROCK WALL**

The wall still appears to be in good condition and fits the description in the original recording. Dry stacked stone walls were commonly constructed in the American era prior to the general advent of barbed wire in the 1880's. Although these features are still constructed for landscaping purposes, the original walls are usually boundary markers or field fences. This particular wall appears to be part of a larger project consisting of several walls and never completed (as demonstrated by a pile of unused stone at the end of one wall segment).

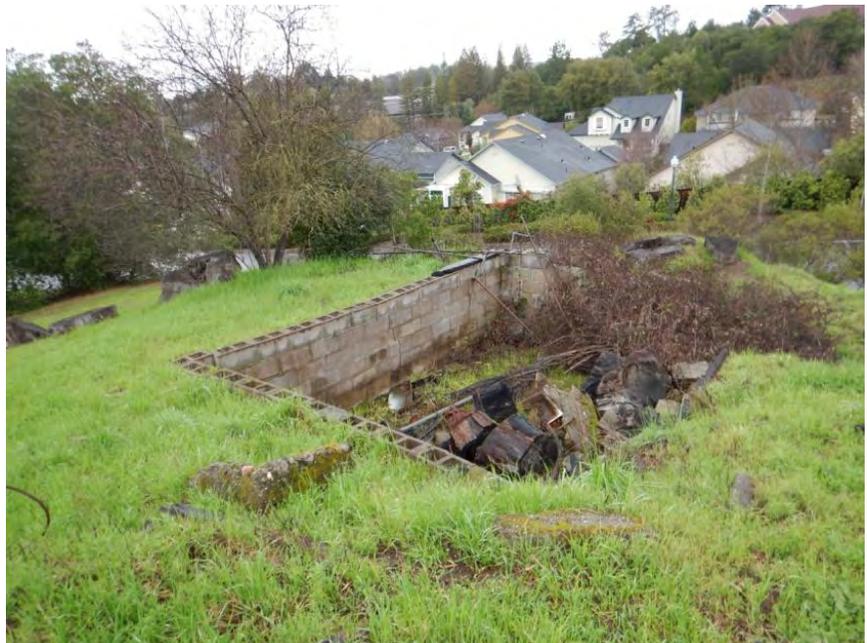
**FIGURE 11 -- THE REMAINS OF THE HOUSE RECORDED AS CA-SON-1766H**

The liberal use of cinder block indicates that the house may not have been as old as originally thought.

The residence recorded in 1989 is no longer present. The now exposed cinder block lined basement indicates that the addition noted in the 1988 survey form had a foundation added sometime after about 1960. Some remnant architectural features remain, including a metal shed to the south of the residence site. The apparent features appear to date to the mid twentieth century or later. There may be a potential for subsurface resources such as trash pits or outhouse shafts to be present, but none were observed. The building was apparently plumbed and therefore is unlikely to have had an associated outhouse. If it was an older building that was placed on a newer foundation, there is a potential for features associated with the earlier uses.

The presence of a cinder block basement indicates that, although the house may have been older, the foundation was at least partially replaced in the middle of the Twentieth Century. This compromised the integrity of the architectural feature. No evidence of the possible privy feature could be found. Several piles of debris were examined, and no artifacts were observed that could be placed earlier than the 1940's or fifties. Other features, described below, indicate that the residential use of the property may date to at least the early 20<sup>th</sup> century and possibly the late 19<sup>th</sup>. There is no indication that archaeological features associated with the early residential use of the property are present and the architectural feature that inspired the recordation is no longer present at all. In the opinion of the author, CA-SON-1766H lacks integrity and is not eligible for inclusion on the California Register of Historic Sites.

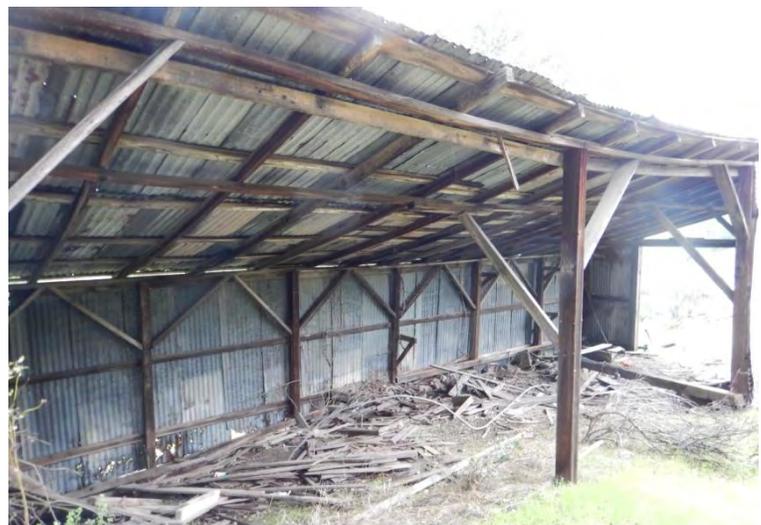
**FIGURE 12 -- THE METAL SHED**

The abandoned house recorded as CA-SON-1766H is no longer present. Twentieth century debris, a deteriorating metal shed, some remnant landscaping plants, and a large pit mark the location formerly occupied by the house. The large Eucalyptus trees visible in the 1988 photographs are now stumps.

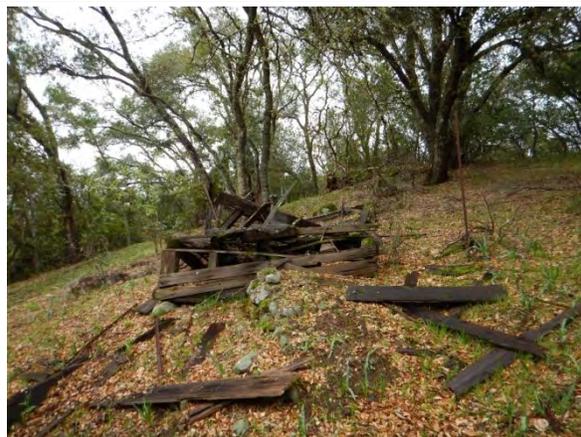
**FIGURE 17 -- THE WATER TANK PLATFORM**

the tank house is not uncommon in rural buildings where the reuse of materials is common.

As with the previous feature, the tank house/platform is very deteriorated. One of the metal hoops that formerly restrained the redwood tank was the identifying artifact. The tank house along with the pump house above probably formed the original water system for the residence. As with the well feature, wire nails were used in the construction of the platform, indicating a 20<sup>th</sup> century origin.

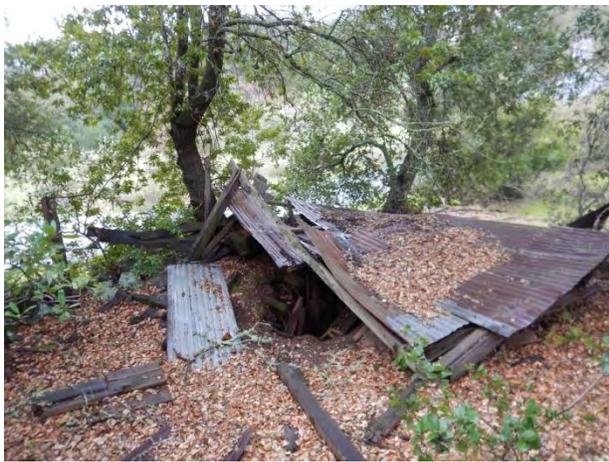
**FIGURE 18 -- THE WELL AND COLLAPSED WELL HOUSE**

1. **(ARS 16-005-1), Well and Pump House.** The first feature observed is the remnant of a well and pump house adjacent to the stone wall along the south side of the property. The remains of a wooden shed overlie a pit about 30 inches across that appears to be at least four feet deep. A few stones can be seen around the lip of the pit, but it does not appear to be stone lined. A pipe extending up out of the pit appears to have been connected to a wind or electric pump that occupied the shed. The building is now collapsed into a pile of wood over and in the pit. A rusted electrical box attached to the shed indicates that an electric pump was probably used. The size of the pit indicates that the well may have been hand dug, and may predate the pump remnants.

The well/pump house is in a very deteriorated condition, and appears to have been built in the 20<sup>th</sup> century. Wire nails, which were not generally available until after 1900, were observed in the wooden planks. An electrical fuse box was also observed. These features are probably the original water source for the former house that lies below the tank on the hill.

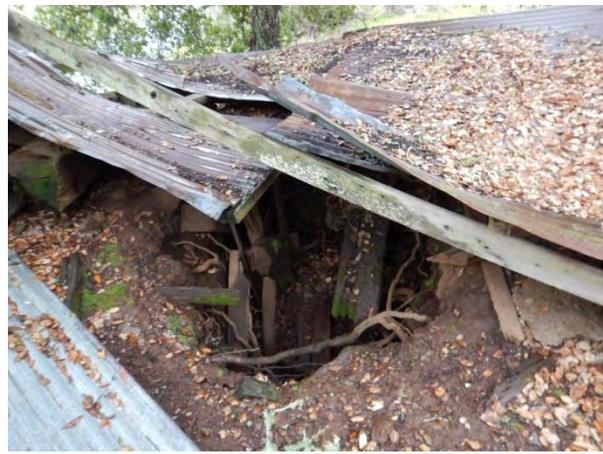
**FIGURE 19 -- A CLOSER LOOK AT THE WELL**

The connection between the well and the water tank by a galvanized pipe clearly indicates the residential association. Examination of the well with a light indicates that plant debris is present, but it has apparently not been used as a disposal site, a common fate of such features on abandonment.

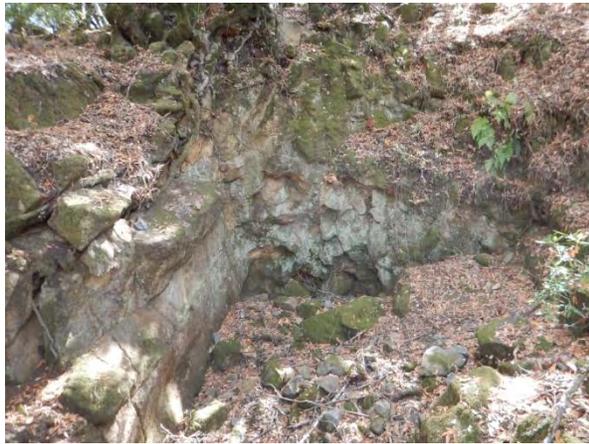
**FIGURE 22 -- ONE OF THE QUARRY PITS**

3. **(ARS 16-005-3) Paving Stone Quarry.** Above the tank house or platform just below the crest on the north side of the hill are three large horizontal pits that are the remnant of a paving stone quarry. The pits are at least ten feet across, parallel, and penetrate 20 to 30 feet into the stone outcrop. Stone debris from the manufacture of paving stones underlies an apparent road access along the front of the open pits. Dense vegetation in the area prevented a thorough examination. No record has been found to indicate a commercial quarry at this location, although that is quite possible. Compared to the similar quarries from this industry located in Annadel State Park, in Bennett Valley and on the western flank of Sonoma Mountain, this is a minor example. A check of all available references has produced no information on this small quarry.

The third newly observed feature is the group of three quarry pits on the north face of the crest of the hill. The pits are heavily overgrown, and thus not easily examined. No features other than the three pits, quarrying debris and a possible access road were seen.

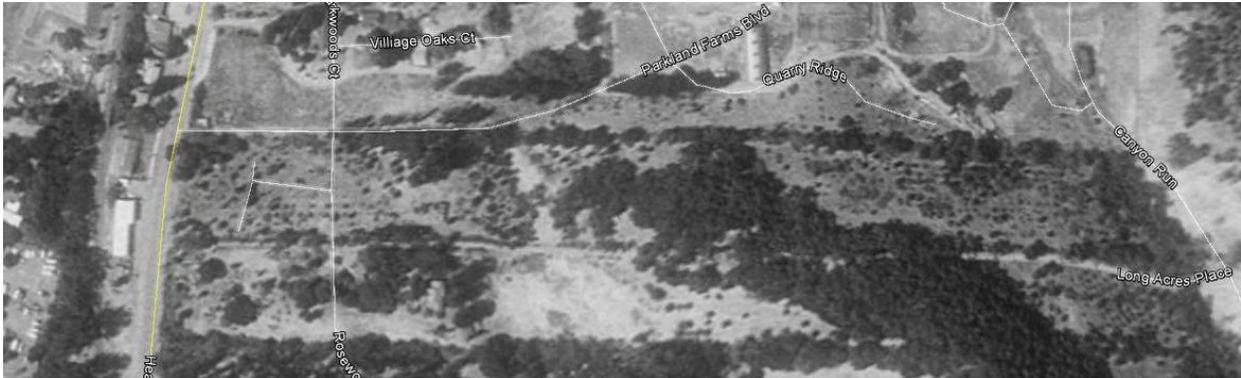
**FIGURE 27 -- 1993 AIR PHOTO OF THE PROJECT AREA**

The patterned vegetation in the eastern third of the parcel indicates a possible orchard or vineyard. The parcel continues to the right, across Canyon Run, but no cultural features were observed in this photo.

Examination of an air photo from the 1960's suggested that an orchard may have occupied an area in the eastern part of the parcel that would now lie on the west side of Canyon Run. No remnant fruit trees or other agricultural artifacts were observed in the inventory. The area is now recognizable as an area of disturbed vegetation, which is not significant under CEQA. Lacking physical evidence, no archaeological feature has been observed. The former orchard is an historic feature of the landscape, but it is no longer present.

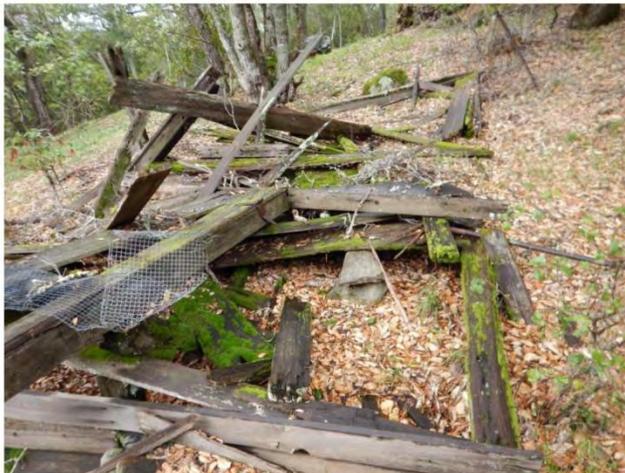
The collapsed platform and water tank

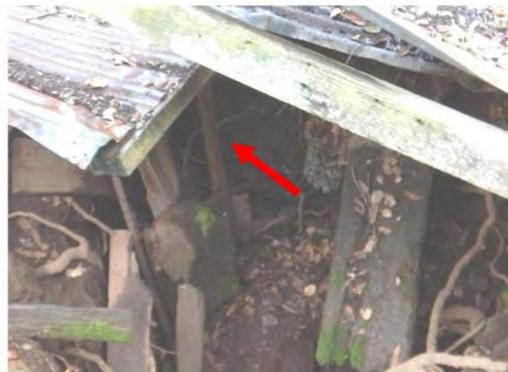
The well showing the vertical water pipe (red arrow).
