PRELIMINARY GEOTECHNICAL STUDY REPORT

PARKLAND FARMS SUBDIVISION
120 PARKLAND FARMS BOULEVARD
HEALDSBURG, CALIFORNIA

3047.04.01.1

June 11, 2015

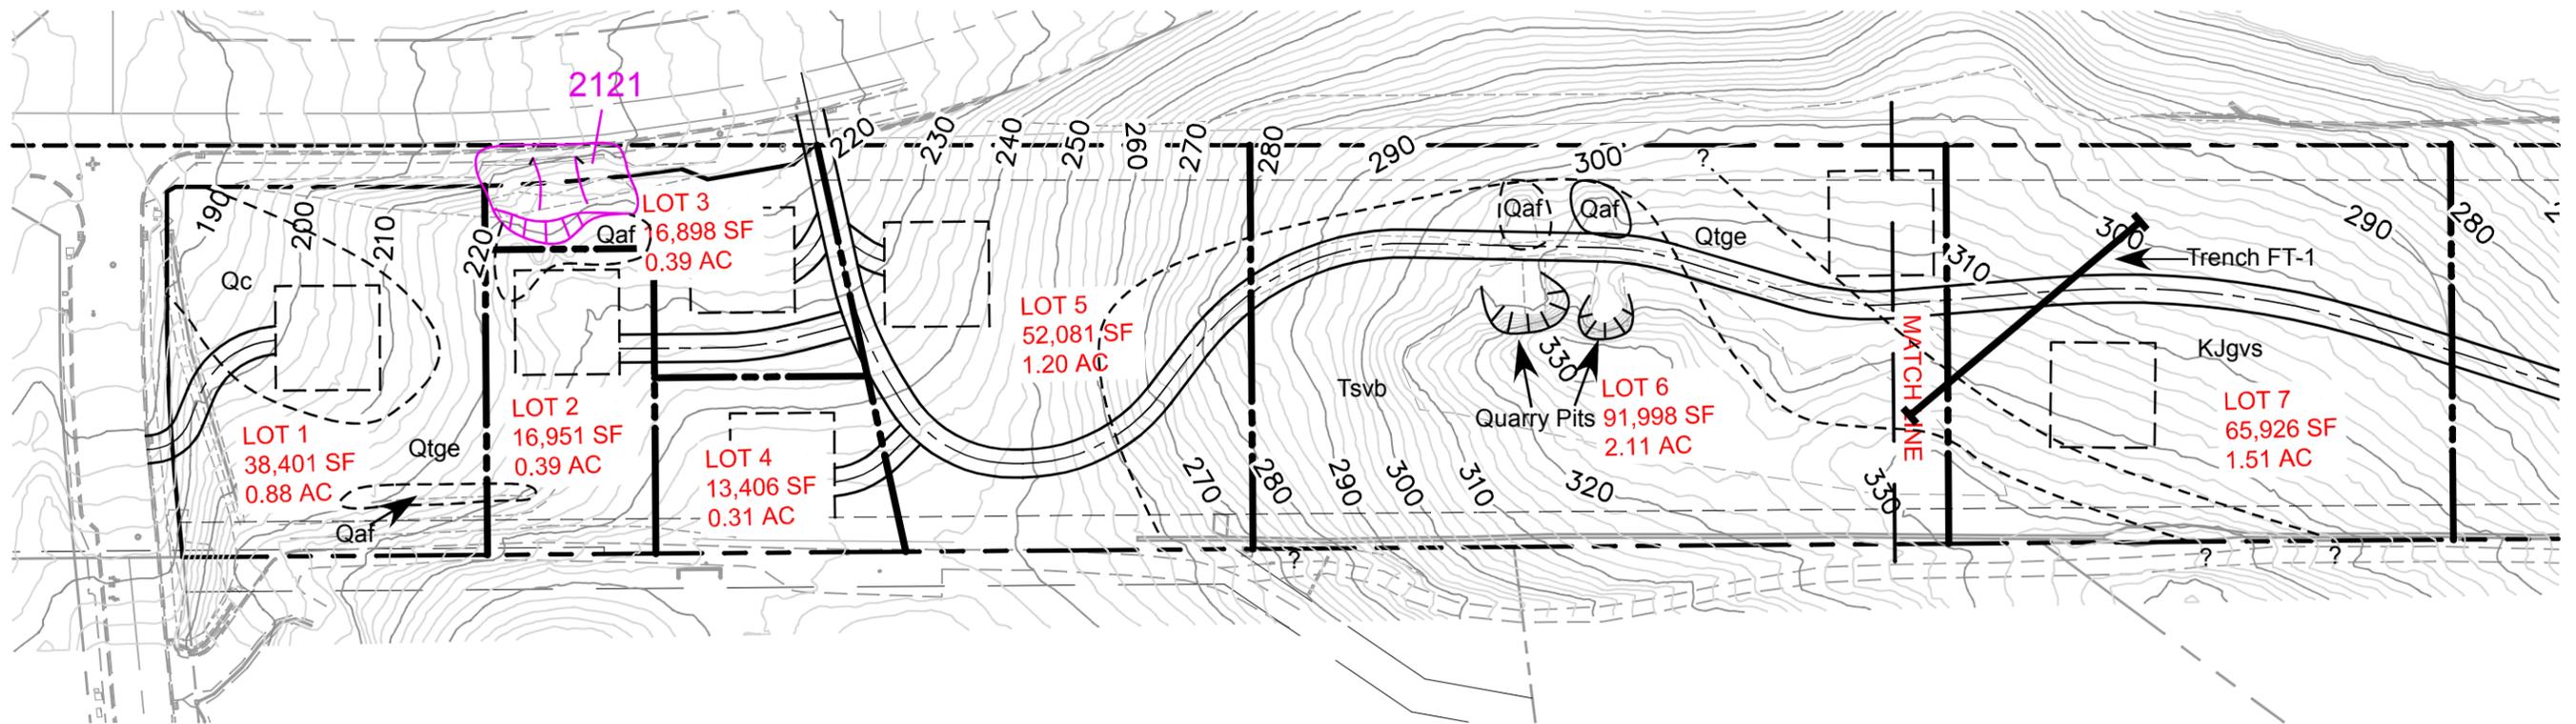
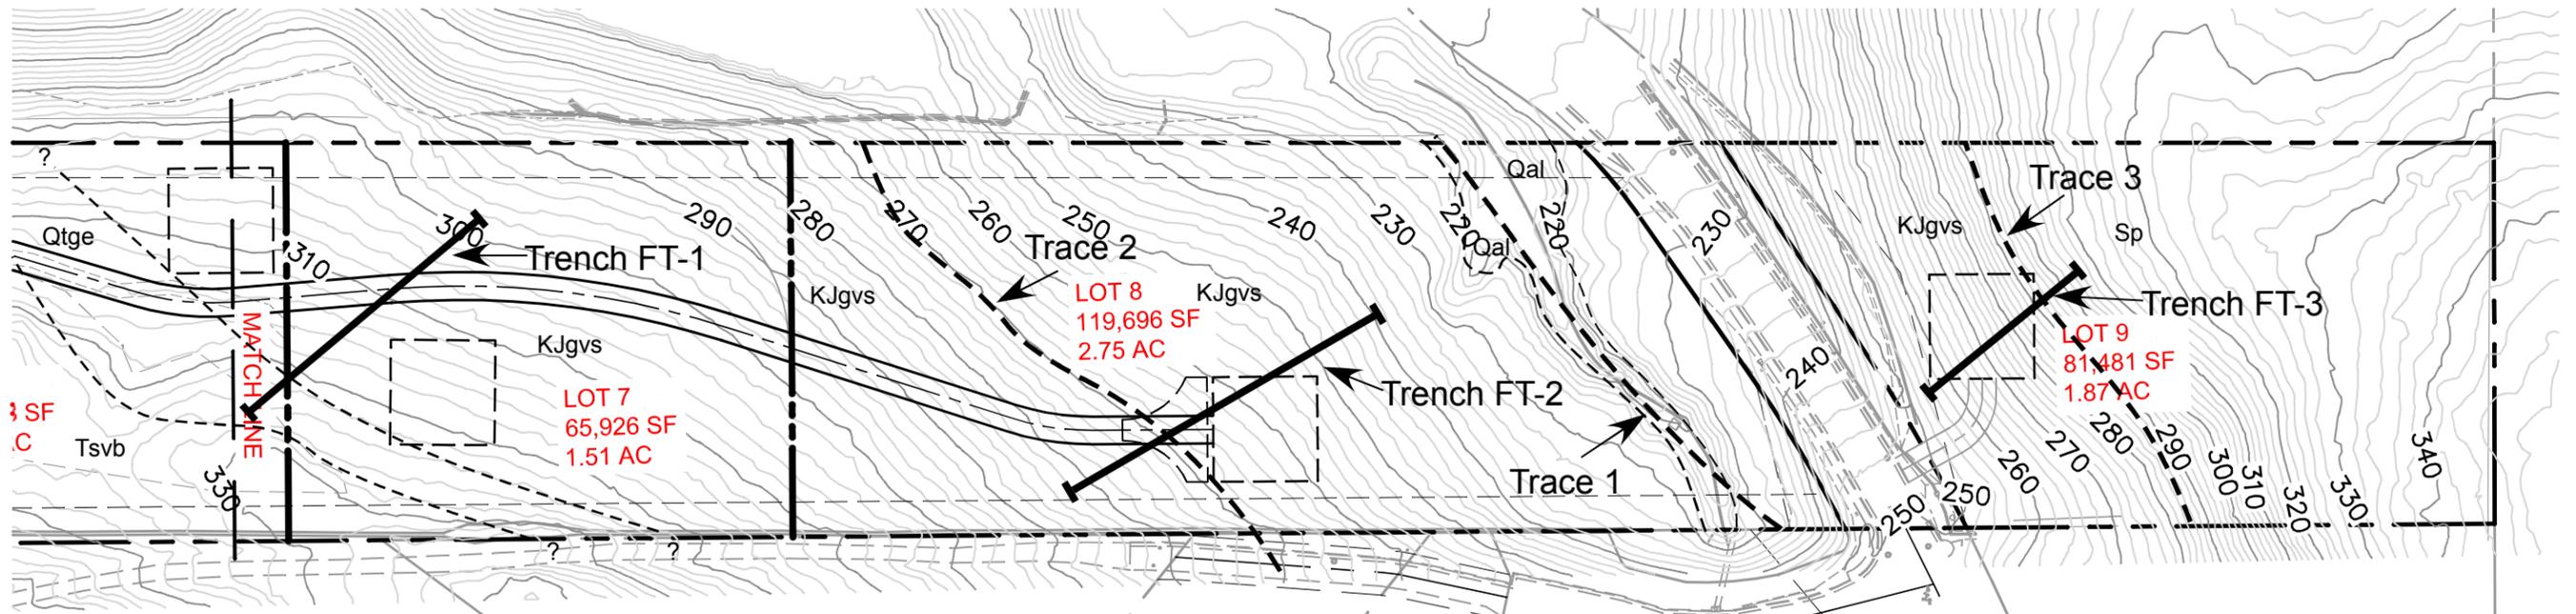
<p>EXPLORATION PLAN AND GEOLOGIC MAP Parkland Farms Subdivision 120 Parkland Farms Boulevard Healdsburg, California</p>	<p>PLATE 2</p>
Job No: 3047.04.01.1	Date: JUN 2015

A trace of the Healdsburg Fault Zone is mapped crossing the eastern portion of the site, in the vicinity of Lot 8. This is identified as Trace 1 on Plate 2. Recent work by other consultants in the immediate vicinity of the site have identified that this trace should be considered active. An

Published landslide maps (Huffman, 1980) reviewed do not indicate large-scale slope instability at the site. However we did observe one landslide at the site during our study. The observed landslide is mapped on Plate 2 and consists of an active translational slide that appears to be between 5 and 20 feet deep.

Based on the investigation and analysis conducted in our fault study for the project, we judge that an active trace of the Healdsburg fault traverses the site through the incised drainage that crosses the eastern portion of Lot 8. This fault trace is depicted as Trace 1 on Plate 2. Several other northwest-trending Earthquake Fault Zones exist in close proximity to and within several miles of the site (Bortugno, 1982). The shortest distances from the site to the mapped surface expression of these faults are presented in the table below.

As shown on Plate 2, the building areas considered for Lots 2 and 3 fall within 50 feet of an active landslide. The building areas should be moved to establish a 50-foot setback from the landslide, or alternatively the active landslide could be repaired and setbacks would only be needed to address slopes steeper than 2:1 in the area.
