*Accessibility Evaluation
for*

**City of Healdsburg, CA
Community Services and
Parks & Recreation Department**

2017

julee quarve-peterson, inc.

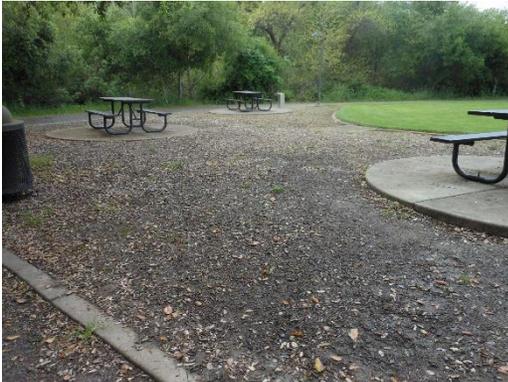
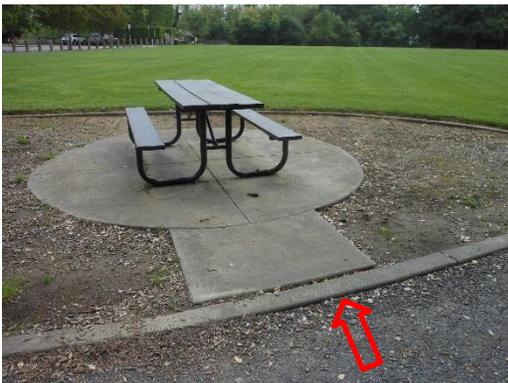
Open Field

There are 3 picnic tables, each positioned on a concrete pad, located at the south corner of the park and 3 more on the west side. Currently none of these tables is located on an accessible route and do not provide a wheelchair space with a forward approach.

Priority 2- Replace a minimum of 1 of the tables at the north end of the park with a style that provides a wheelchair space with a forward approach.

Ensure the table style selected allows for clear ground space surrounding the table. (Currently a 12' diameter circle.) *ADA 902.2. Clear ground space recommended based on ABA Table 1011.2.1*

Priority 2- Modify the surface material used for the accessible route or the concrete border to reduce the vertical change to 1/4" maximum. *ADA 303.2*

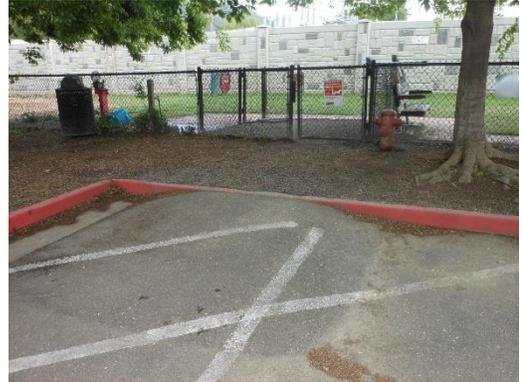
Dog Park

A dog park is located to the east of the parking lot. This dog park is intended for small dogs (less than 17" tall). A larger 1.5-acre dog park is located at Villa Park for dogs of all sizes.

Priority 3- Create an accessible route to the dog park entry from accessible parking. ADA 206.2.2, 402.2

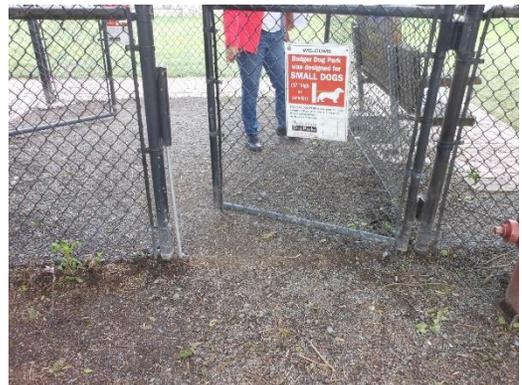
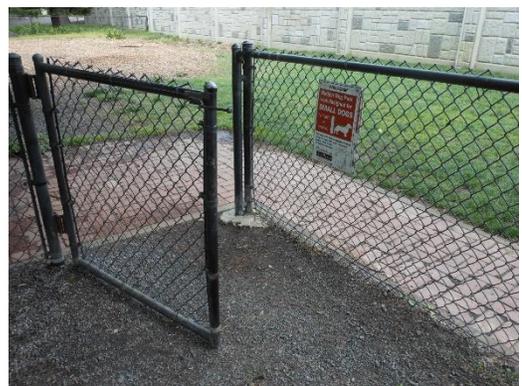
Entry Vestibule

A gated vestibule is used at the entry to the dog park. Maneuvering clearance is not currently provided at the interior gate. The latch hardware to operate the gates is currently at 48" (within reach range) although it is located only the one side of the fence (requiring reaching over the fence to operate the hardware in order to exit).

Priority 2- Modify the swing of the interior vestibule gate (swing "in" to the vestibule, but reverse the hinge and latch side). ADA Table 404.2.4.1

Priority 3- Replace the operable hardware at the gate with a style that can be operated from both sides. ADA 404.2.7

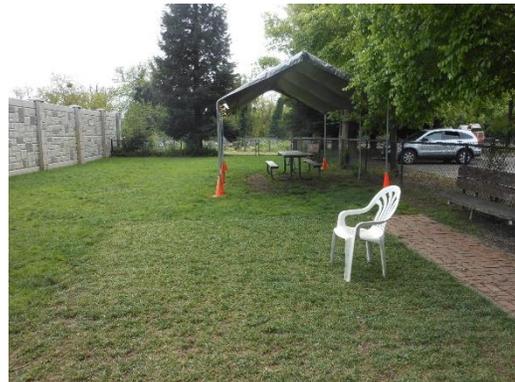
Picnic Tables & Benches

A seating and gathering area at the south end of the park includes 1 picnic table (movable), 1 fixed benches and a shade structure. The table is not currently located on an accessible route and does not provide a wheelchair space with a forward approach.

Priority 3- Provide picnic tables that allow for a wheelchair space with a forward approach. ADA 902.2, 206.2.2

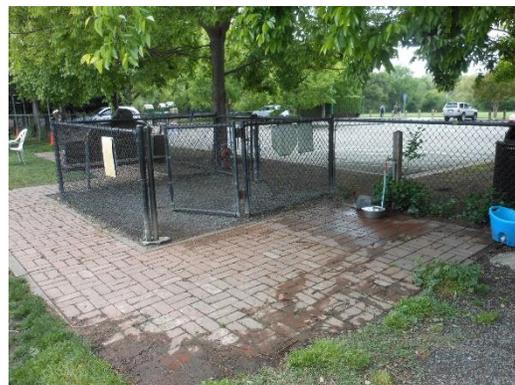
Accessible Route

A combination of surface materials have been used throughout the dog park. A paver route is provided from the entry vestibule to 1 of the benches, but it does not extend to the shade structure and picnic table. The surface material within the entry vestibule is a semi-compacted gravel (the gravel base is compacted, however there is loose gravel on top).

Priority 3- Create an accessible route throughout the dog park, connecting to the features provided (picnic tables and benches). ADA 206.2.2

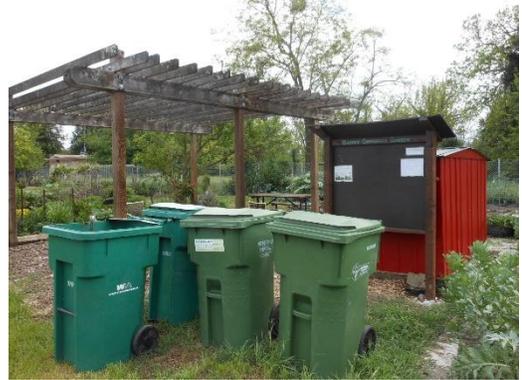
Common Area

A common area is located near the center of the community garden and provides a shade structure, storage shed and picnic tables. There is not currently an accessible route to the common area and the picnic table does not provide a wheelchair space with a forward approach.

Priority 2- Relocate the common area closer to the entry and located along the same accessible route created to serve 1 of the garden plots.

Priority 3- Provide an accessible picnic table with a forward approach located at an accessible location. ADA 902.2.

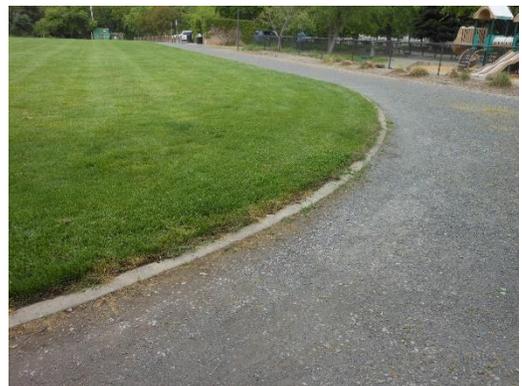
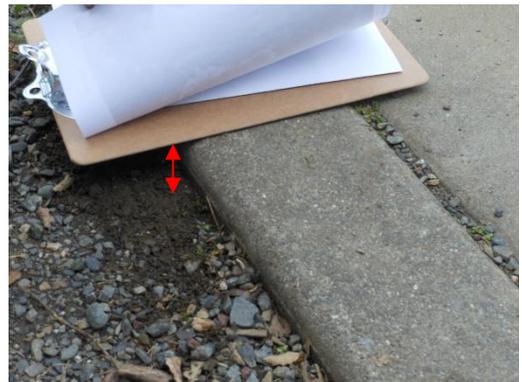
Accessible Route

Perimeter

A compacted aggregate route is provided throughout the park and around the perimeter of the grass field. The base of the aggregate was heavily compacted at the time of the site visit, although there was loose gravel on the top surface. The aggregate route is bordered by a concrete curb. There is currently a $\frac{3}{4}$ " – 1" vertical rise between the compacted aggregate and the concrete curb (vs. $\frac{1}{4}$ " maximum). (It is necessary to cross this curb to reach site amenities, including: trash, drinking fountains, portable toilets, picnic, etc.)

Priority 2- Modify the surface material used for the accessible route or the concrete border to reduce the vertical change to $\frac{1}{4}$ " maximum. *ADA 303.2*

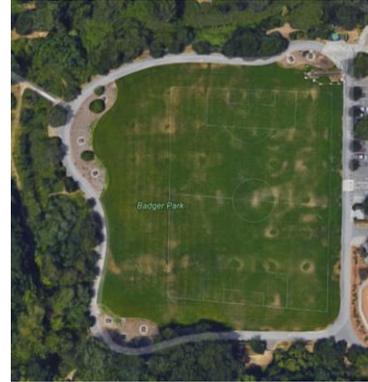
Play Field

Although not in use at the time of site visit, the open grass field is used as a playing field for soccer, football etc. during the sports season.

Priority 2- When the grass is being used as a playing field, ensure an accessible route is provided up to the boundary of all fields and to any team or spectator seating (if provided). The distance of the route will depend on the location and orientation of the field(s). *ADA 206.2.2*

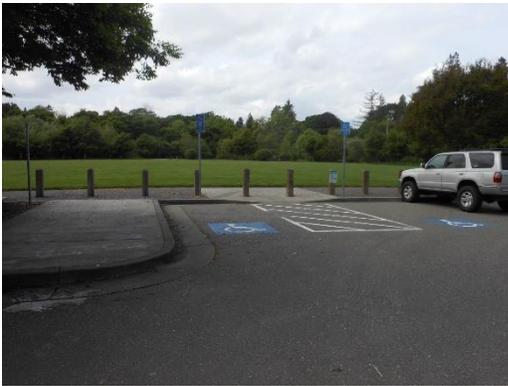
Parking

Quantity

Based on the total number of parking spaces within the parking lot, a minimum of 3 accessible parking spaces are required. Currently 2 spaces have been designated as accessible.

JQP, Inc. recommends designating the additional space near the dog park entry.

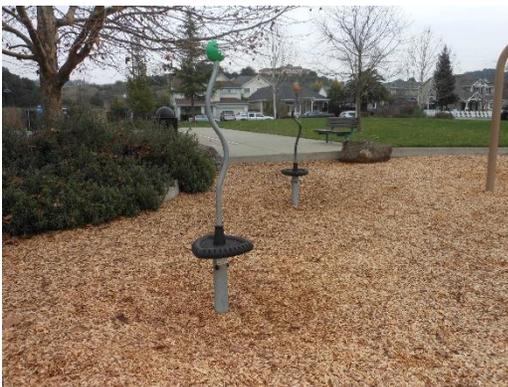
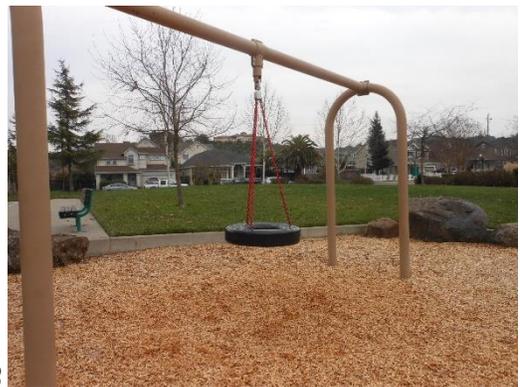
Area B

A concrete ramp creates an accessible route into the loose fill surface material of the defined play area at the to-fro strap swings. There is currently a 3" vertical drop between the end of the concrete ramp and the surface material.

Maintenance- Add loose fill surface material (or redistribute existing material) to reduce the vertical change to ¼" maximum. *ADA 303.2*

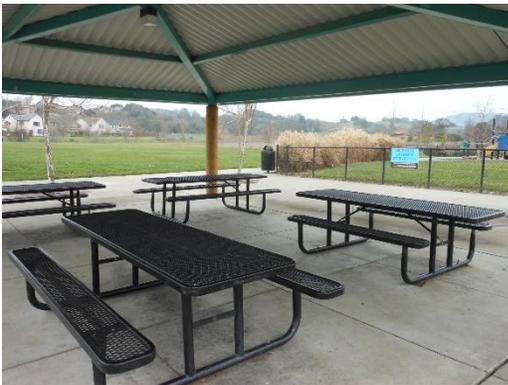
Picnic Tables

There are 3 picnic tables located throughout the park. The tables are located on concrete pads and are linked to the accessible route. *This is a good example of accessibility.*

Priority 2- Provide a minimum of 1 picnic table with a wheelchair position with a forward approach. (Based on the table style provided, the concrete pad may need to be enlarged to provide adequate clear ground space around the picnic table.) *ADA 902.2. Clear ground space recommended based on ABA Table 1011.2.1*

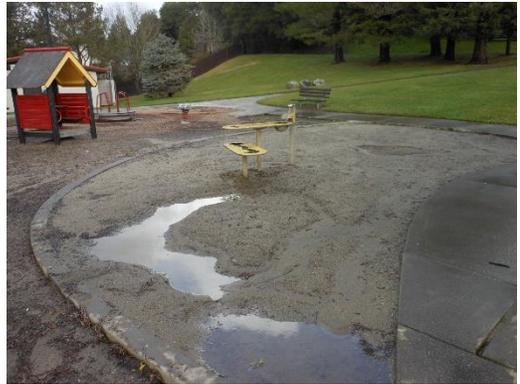
Area D

A concrete ramp creates an accessible route into the loose fill surface material of the defined play area. There is currently a 1" vertical drop between the end of the concrete ramp and the surface material. Much of the loose fill surface material had been washed away at the time of site visit.

Maintenance- Add loose fill surface material (or redistribute existing material) to reduce the vertical change to ¼" maximum. *ADA 303.2*

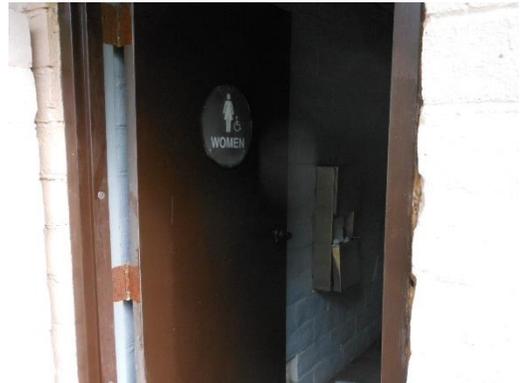
Door Approach

Wing walls provide privacy at the entry doors. The walls reduce the maneuvering clearance on the push side of the door to 45" (vs. 48" minimum where a closer is provided).

Priority 4- Modify/remove the wing walls to increase the depth on the push side of the entry door. *ADA Table 404.2.4.1*

Note: The clearance at the door complies where the door does not have a closer (42" minimum). A closer is provided at this door, however the door is propped in the "open" position.

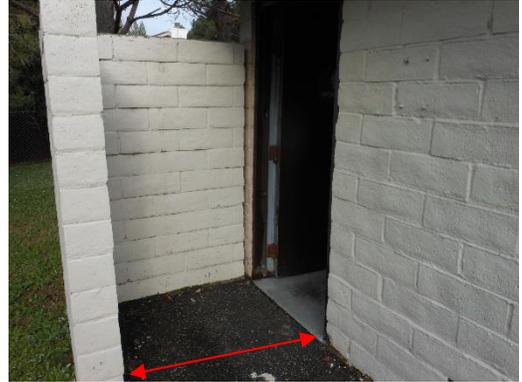
Door Approach- Men's

There is currently a drainage grate located in front of the entry door to the men's toilet room. The grate has openings that allow passage of a sphere greater than 1/2" within the maneuvering clearance.

Priority 3- Replace the drain cover with a style that does not allow passage of a 1/2" sphere. *ADA 302.3*

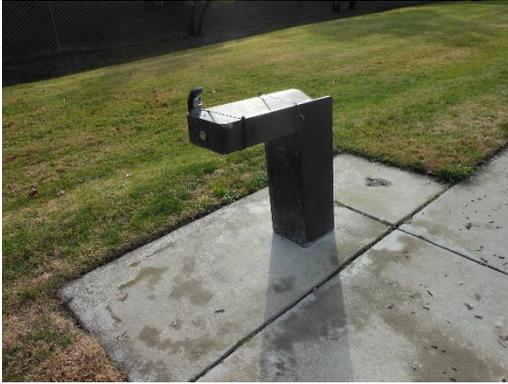
Drinking Fountain

There is currently 1 drinking fountain provided on the site. The drinking fountain is located on an accessible route and provides a forward approach with knee and toe clearance. *This is a good example of accessibility.* A standing height drinking fountain is not currently provided.

Priority 2- Provide a standing height drinking fountain with a spout at 38"-43" AFF (a minimum of 2 drinking fountains are required at each site). ADA 211.2, 602.7

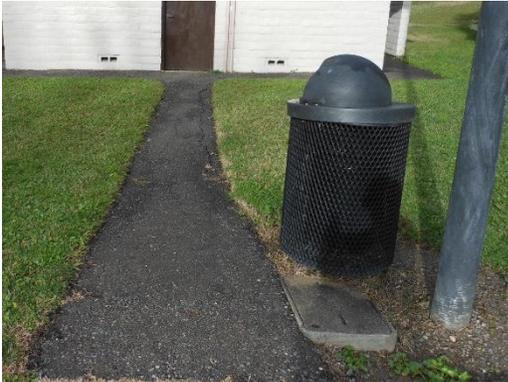
Trash receptacles are located throughout the park, including 1 located adjacent to the route to the toilet rooms building and 1 on an accessible route below the picnic shelter. *This is a good example of accessibility.*

Maintenance- Ensure that when trash is emptied/collected, the lid is positioned facing the accessible route so the opening is located within reach range. ADA 308

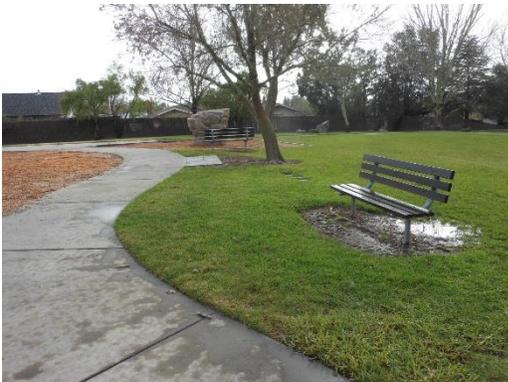
Benches are located around the perimeter of the park. Currently 2 of the benches are positioned adjacent to the route while 6 are located in the grass.

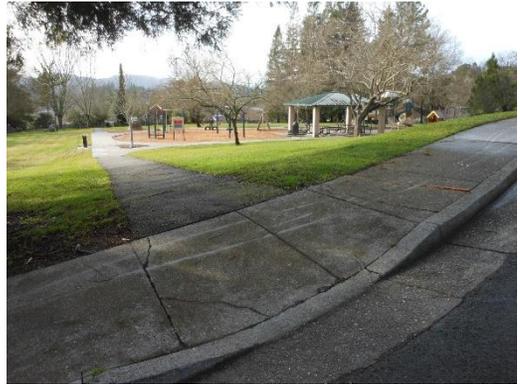
East

The asphalt route from the city sidewalk along Prentice Drive towards the park amenities is currently as steep as 9.8% (vs. 5% maximum) with up to 8.6% cross slope (vs. 2% maximum).

Priority 2- Reconfigure the route to reduce the slope and cross slope in order to create an accessible route to the park amenities. *ADA 403.3*

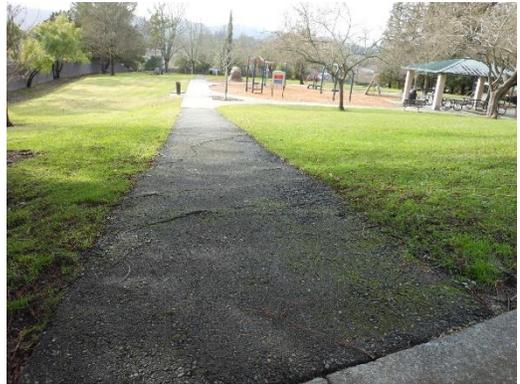
Northwest

The route to the NW corner of the park (Parkview Drive) is currently in rough condition; the slope of the route is currently as steep as 16.5% (vs. 5% maximum).

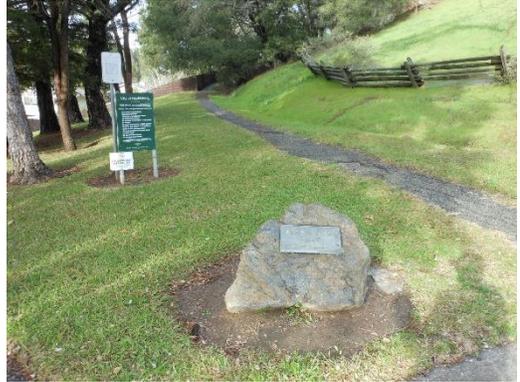
Toilet Rooms

An asphalt route is provided up to the toilet room building. *This is a good example of accessibility.* The route is currently 32" wide (vs. 36" minimum). The slope of the route is currently 12.7% (vs. 5% maximum, or up to 8.33% maximum if handrails are provided).

Priority 3- Widen the route to 36" minimum. *ADA 403.5.1*

Priority 3- Modify/reconfigure the route to reduce the slope. *ADA 403.3*

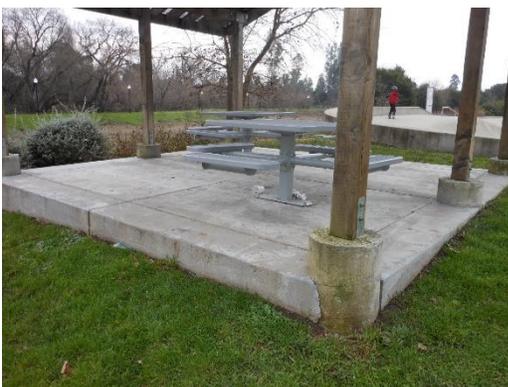
Picnic Tables

There are 2 picnic tables below a shade structure on the north side of the skate park. There is not currently an accessible route to the picnic tables. Currently neither of the picnic tables provides a wheelchair seating position with a forward approach.

Priority 4- Create an accessible route to the picnic tables or provide additional picnic tables at an accessible location. *ADA 206.2.2*

Priority 4- Provide a minimum of 1 picnic table with a wheelchair position with a forward approach. *ADA 902.2.*

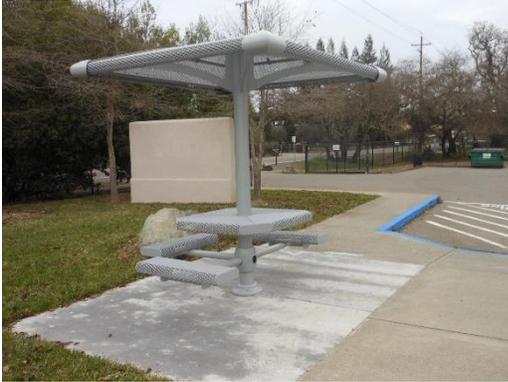
Picnic Table

There is 1 additional picnic table provided near the parking lot. The picnic table has been modified to provide a wheelchair space for a forward approach and is located on an accessible route. *This is a good example of accessibility.*

Note: Although this table is located at the park and provides features of accessibility, it does not have sight-lines to the skate park to allow for supervision (the tables under the shade structure do), which is why providing accessible tables below the shade structure is still recommended.

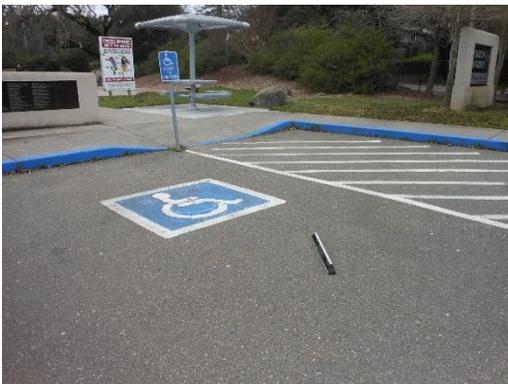
Slope

The slope within the accessible parking space and aisle is currently 2.3% - 3% (vs. 2% / 1:48 maximum).

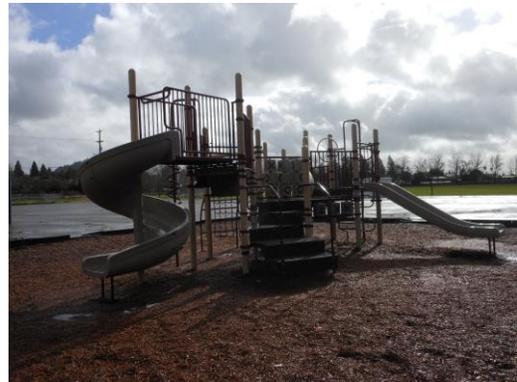
Transfer System

The transfer platform is currently 22" above the surface of the loose fill material (vs. 11"-18").

Maintenance- Add loose fill surface material (or redistribute existing material) to reduce the height of the transfer platform to 11"-18". *ADA 1008.3.1.2*

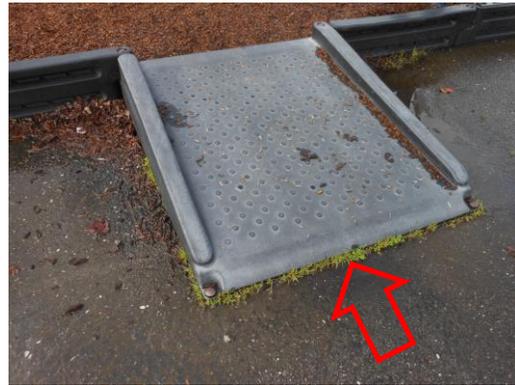
Accessible Route

Plastic ramps have been provided to create an accessible route over the plastic border and into the defined play area. *This is a good example of accessibility.*

Maintenance- Add loose fill surface material (or redistribute existing material) to reduce the vertical change to ¼" maximum. *ADA 303.2*

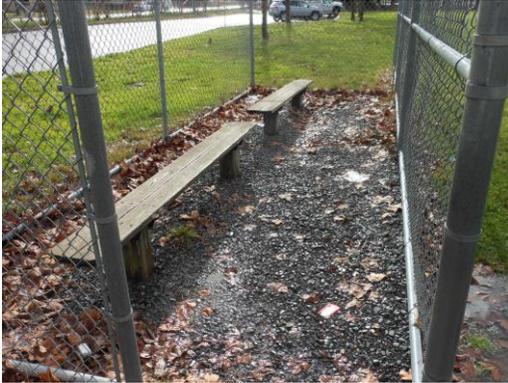
Dugouts

The dugouts do not currently provide space for a wheelchair within the seating area.

Priority 3- Relocate (or replace) the benches within the dugout to provide a wheelchair space. *ADA 221.2.4.1*

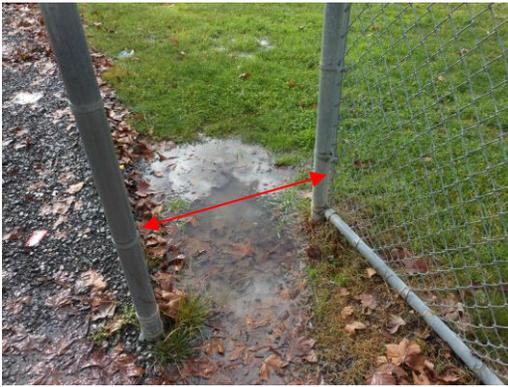
Dugouts

The route onto the field from the 3rd base dugout currently provides a 30" clear opening onto the field (vs. 32" minimum).

Priority 3- Reconfigure the fence to create a 32" minimum clear opening onto the field. *ADA 206.2.2*

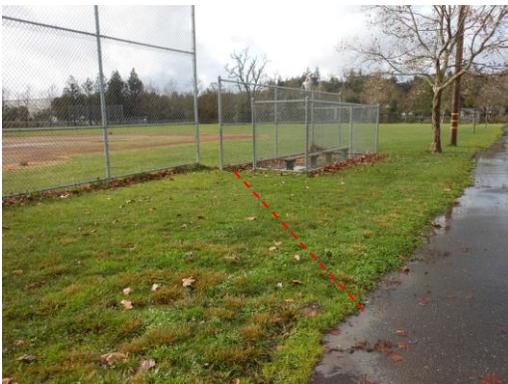
Accessible Route

There is not currently an accessible route from the hard surface court to the ballfields. Currently grass only.

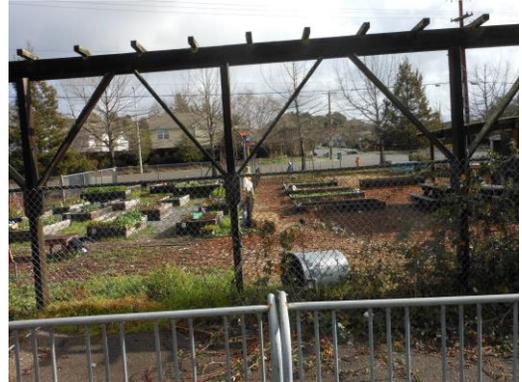
Amenities

There is a greenhouse and water source at the south end of the community garden. The door into the green house has less than a 32" clear opening and the sink is not currently accessible.

Priority 3- Modify the door to the greenhouse to provide a 32" minimum clear opening. *ADA 404.2.3*

Priority 3- Replace the sink with an accessible sink, including a forward approach with knee and toe clearance and insulated pipes. *ADA 212.3, 606*

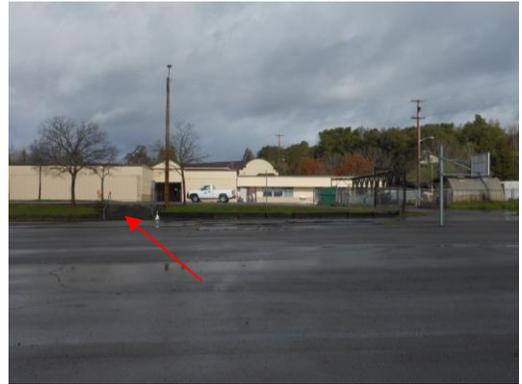
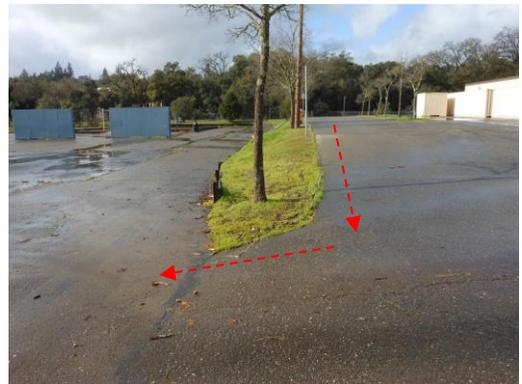
From Parking

There is not currently a pedestrian route between the south parking and the site amenities. The only route is currently a vehicle traffic lane which has a slope of 10.4% for a distance of approximately 20' (vs. 5% maximum or 8.33% maximum if handrails are provided).

Priority 2- Modify the route between the parking and the hard surface court to provide an accessible route. ADA 403, 405

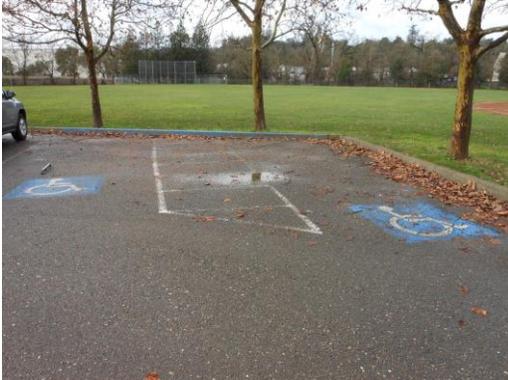
Accessible Parking Spaces

The 2 parking spaces currently designated as accessible are 9' wide and 8'-9" wide and share an 5'-3" wide access aisle. There are not currently signs posted at the head end of the parking spaces. The slope within the aisle is up to 3% (vs. 2% maximum).

Priority 3- Outline the accessible parking spaces with blue paint. *11B-502.3.3*

Priority 4- Modify the surface (or relocate the parking accessible parking spaces) to reduce the slope. *ADA 502.4*

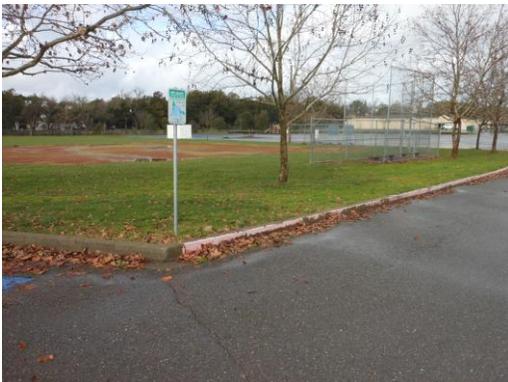
Accessible Route

There is not currently an accessible route from the accessible parking spaces to any of the site amenities they serve (ballfields, play equipment, building, etc.).

See recommendations above regarding accessible route.

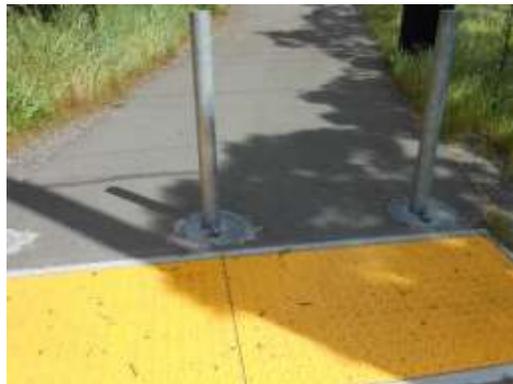
Transitions

Bridges have been provided at locations where the pathway crosses hazards such as Foss Creek. The openings at the entry to the bridges would allow passage of a 1/2" sphere.

Priority 3- Modify the connections/transition at the entry to bridges so the opening does not exceed 1/2". *ADA 302.3*

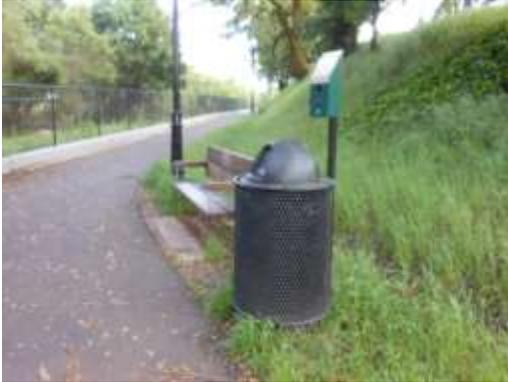
Benches have been provided along the pathway. The benches are typically positioned adjacent to the pathway on a concrete pad. They do not provide space for an adjacent wheelchair position.

Priority 4- Create a hard surface pad adjacent to a minimum of 1 bench to accommodate an adjacent wheelchair position. *ADA 903*

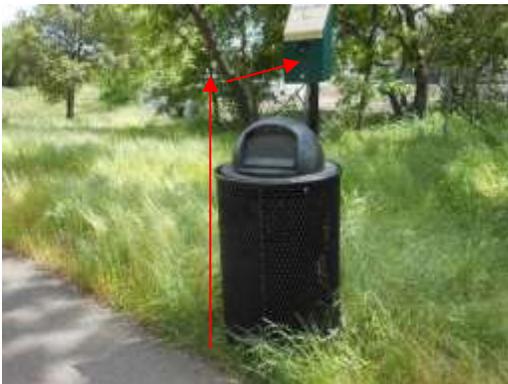
Pet Waste Disposal

There are pet waste disposal bags located at various points along the pathway. They are typically positioned behind the trash receptacle, placing them outside the maximum reach range.

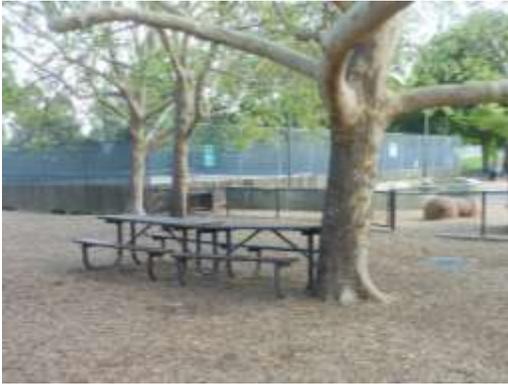
Picnic- Play Area 5-12

There are currently 2 picnic tables located in the loose fill wood surface material between the 5-12 year old play area and the fenced 2-5 year old play area. Currently neither table provides a wheelchair space with a forward approach.

Priority 4- Provide a minimum of 1 picnic table with a wheelchair position with a forward approach.
ADA 902.2

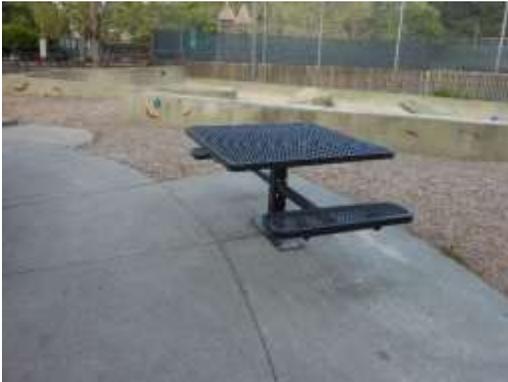
Picnic- Play Area 2-5

There are 2 fixed picnic tables located within the fenced 2-5 year old play area. Currently both of the picnic tables are located on an accessible route and provide a wheelchair space with a forward approach. *This is a good example of accessibility.* Currently the clear ground space has a cross slope of 3.1% (vs. 2% / 1:48 maximum).

Priority 4- Modify the concrete surface to reduce the cross slope to 2% maximum. *ADA 902.2, 305.2*

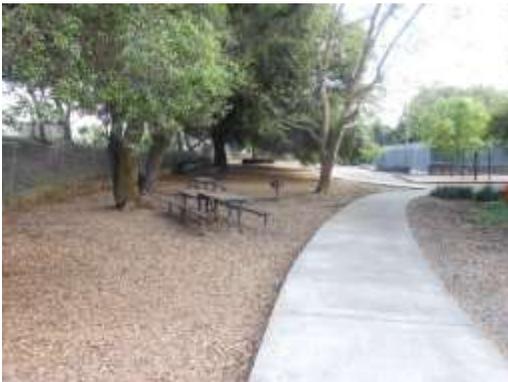
Picnic- Northeast

There are currently 5 picnic tables and a grill located in the grass in the northeast corner of the park. Currently none of the picnic tables provides a wheelchair space with a forward approach.

No action at this time- accessible picnic facilities are provided at the park.

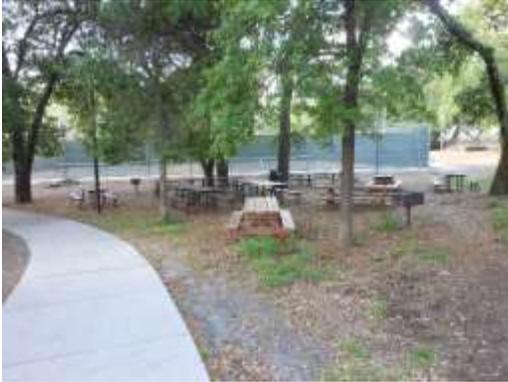
Picnic- South of Tennis

There is a picnic area located in the hilly area to the south of the tennis courts with 13 tables and 3 grills. The tables are positioned in the grass/dirt. Currently none of the picnic tables provides a wheelchair space with a forward approach.

No action at this time- accessible picnic facilities are provided at the park.

Note: Review policies, if this picnic area can be reserved, provide accessible tables and a grill at an accessible location.

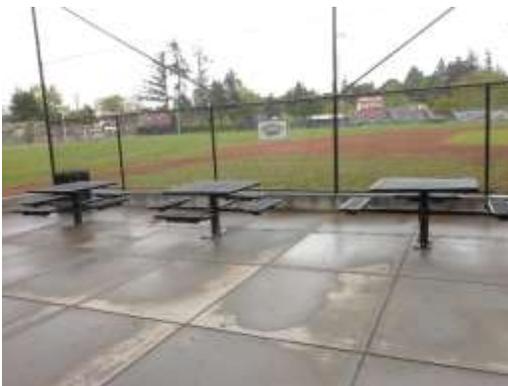
Picnic- McCaffrey Field

There are 3 fixed picnic tables located on the 3rd base side of McCaffrey Field (near the concession stand). The tables are located on an accessible route and 1 of the tables provides a wheelchair space with a forward approach. *This is a good example of accessibility.*

Priority 4- Modify the table base to provide compliant clear ground space. *ADA 902.2, 306.2*

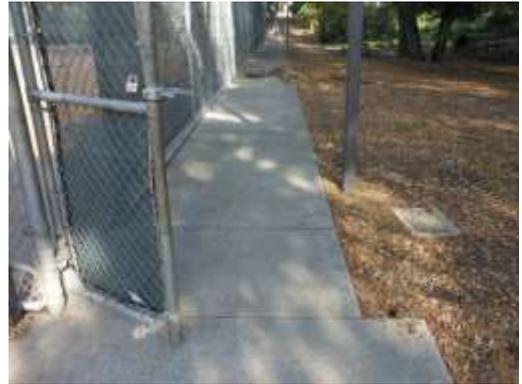
Light Control

The control button for the lights at the tennis courts is currently at 59" (vs. 48" maximum).

Priority 3- Lower the light control to 48" maximum. *ADA 308*

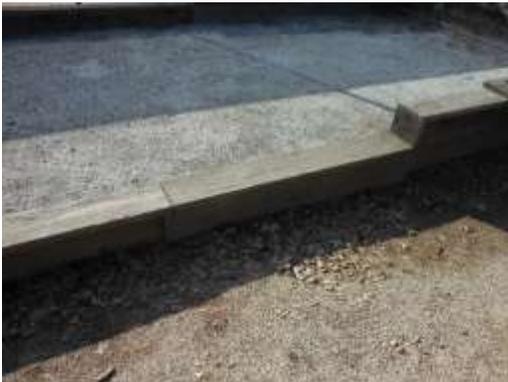
Accessible Route

The bocce ball court is located to the east of the tennis courts. A compacted gravel surface is provided from the existing path to the boundary of the court. One section of border can be removed to create an accessible route on to the court when needed. *This is a good example of accessibility.*

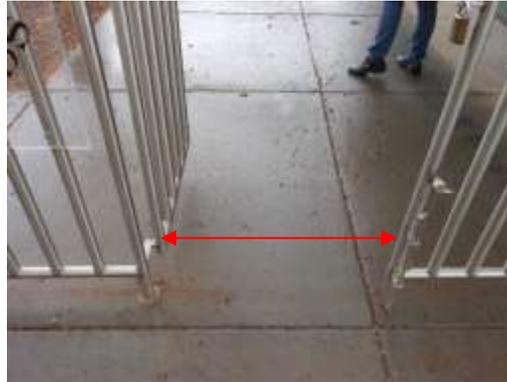
Note: When open to 180° the gates provide a 32" clear opening.

Priority 4- Replace the gates with a style that provides a single leaf with a 32" clear opening when open to 90°. *ADA 402.2.2, 402.2.3*

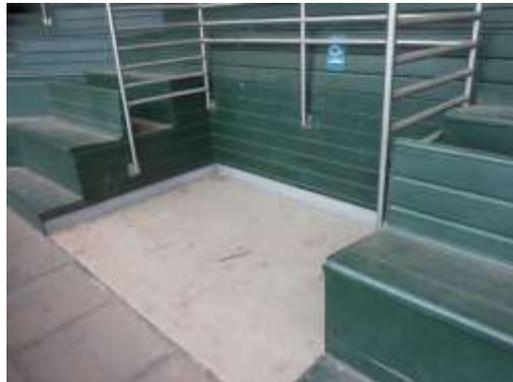
Seating- Grandstand

Wheelchair viewing positions have been integrated in to the front row of the grandstand behind home plate and on the 3rd base side. *This is a good example of accessibility.* Each opening is large enough to accommodate 2 wheelchairs with adjacent companion seating (4 wheelchair positions total). Based on the approximately seating capacity between 301-500, a minimum of 6 wheelchair spaces are required.

Priority 3- Modify the bleacher grandstands to provide 2 additional wheelchair spaces. *ADA Table 221.2.1.1, 802.1.2,*

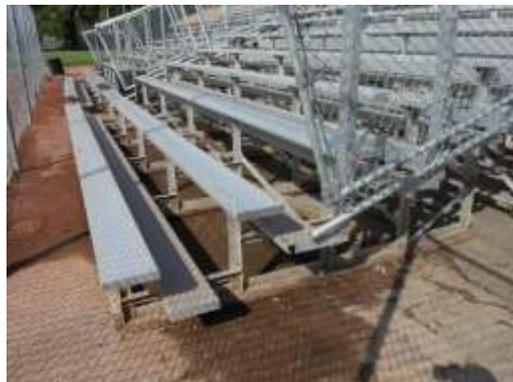
Bleacher Seating- 1st Base

Bleacher seating is provided on the 1st base side of the field (there are 3 sets of bleachers, each with 10 rows). There is space adjacent to the bleachers for wheelchair spaces, but they are not integrated into the bleachers.

Priority 3- Provide integrated wheelchair positions, with adjacent companion seats, in the bleacher system. *ADA Table 221.2.1.1, 221.3*

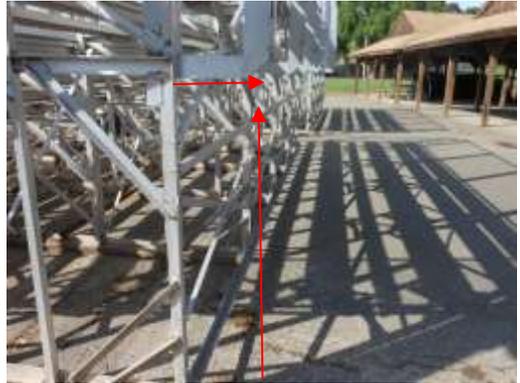
Bleacher Seating- 1st Base

The backside of the bleachers currently protrudes into the circulation route 13" at a height of 55".

Priority 2- Modify the backside of the bleachers or add a trim detail to eliminate the protruding hazard.
ADA 307

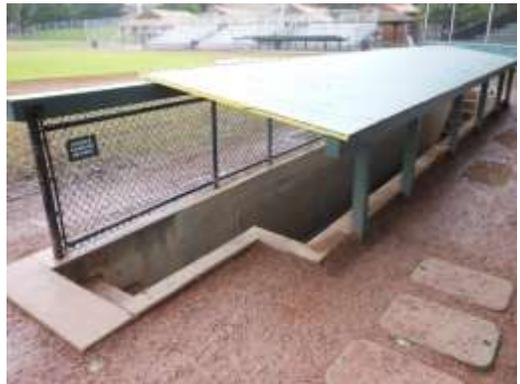
Route to Field/Dugout

An accessible route is provided from the grandstand to the boundary of the playing field.

Priority 2- Create an accessible route into the dugout or modify the dugout so it is on an accessible route. *ADA 206.2.4, 206.7.9*

Priority 3- Modify the bench in the dugout to provide a wheelchair position. *ADA 221.2.1.4*

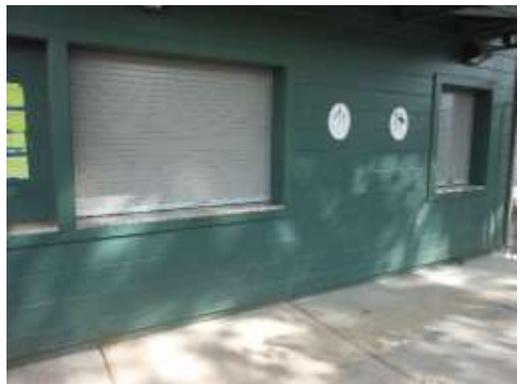
Grandstand

The ticket window and concession counter in the grandstand building are currently at 33". Doors individual locker, storage and concession rooms are located on grade and have lever style hardware. *This is a good example of accessibility.*

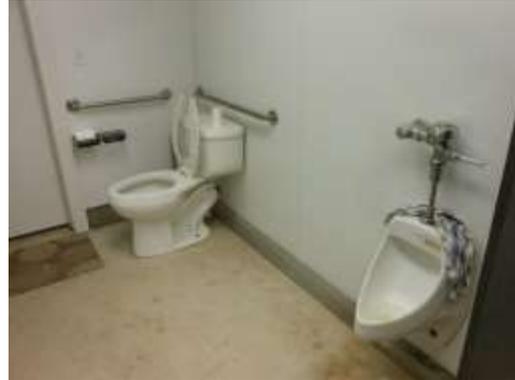
Grandstand- Locker Room

A single-user toilet room is shared between the baseball locker room and the football storage room (at the east end of the grandstand). Features of accessibility were provided at the time of construction although it does not fully comply.

Priority 4- Relocate the rear wall grab bar. ADA 604.5.2

Priority 4- Replace the toilet with a style has the flush lever on the open side of the toilet. ADA 604.6

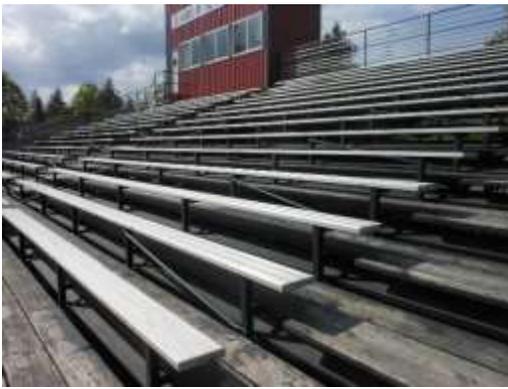
Grandstand Seating

The grandstand seating has a ramp on the east end that is used by all spectators. The ramp currently has a slope of approximately 17% for its 50" rise without an intermediate level landing (vs. 8.33% maximum and a level landing for each 30" vertical rise). The surface of the ramp is wood boards which have spaces between that would allow passage of a 1/2" sphere.

Priority 1- Create an accessible route to the grandstand seating area. *ADA 206.2.4*

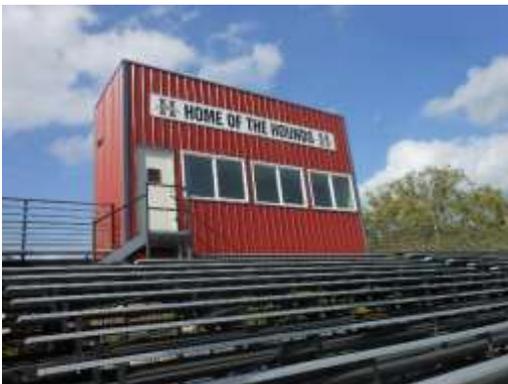
Grandstand Seating

The grandstand does not currently provide any wheelchair spaces integrated into the seating area with adjacent companion seats. Based on the approximately seating capacity between 301-500, a minimum of 6 wheelchair spaces are required.

Priority 2- Create a minimum of 6 wheelchair spaces in the grandstand seating area. *ADA Table 221.2.1.1, 802.1.2,*

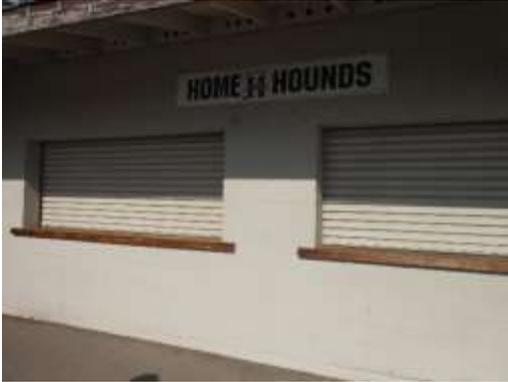
Grandstand- Press Box

A press box is provided at the top of the grandstand bleacher system. There is not currently an accessible route provided to the press box.

Priority 2- Ensure that all activities taking place in the press box (running the game clock, announcing, etc.) can be relocated to an accessible location as needed.

Note: An accessible route is not required to the press box based on *ADA 206.2.7 Exception 1*

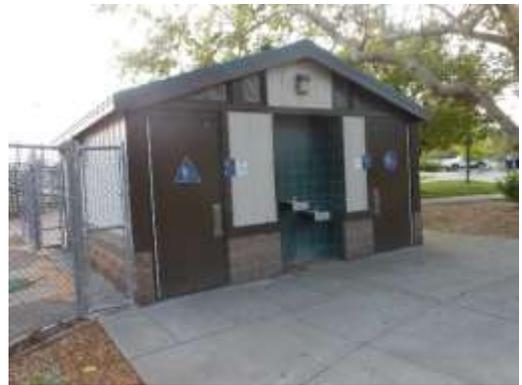
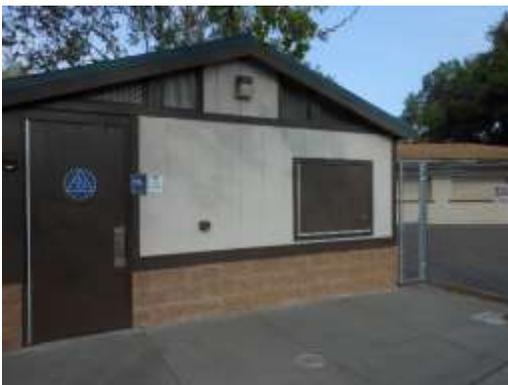
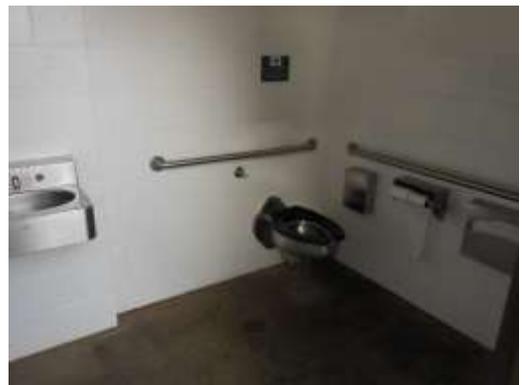
North

A toilet room building is provided at the north end of the park near parking, playground and the football stadium. There are 3 single user toilet rooms, plus a ticket counter and drinking fountains. Features of accessibility were provided at the time of construction. *This is a good example of accessibility.*

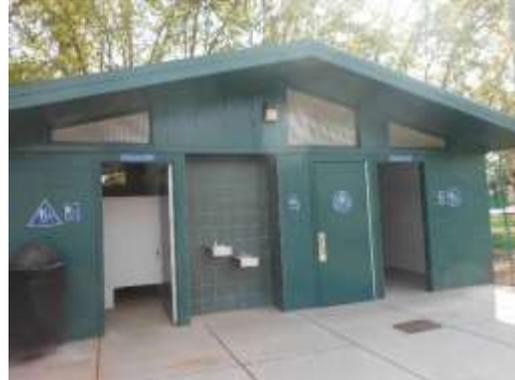
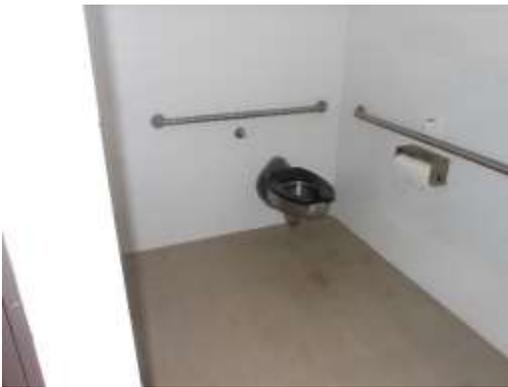
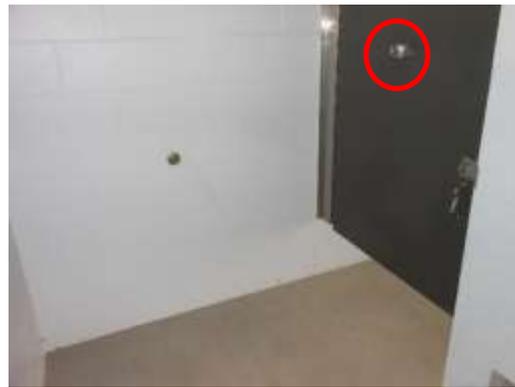
South / Baseball

There is a toilet room building adjacent to the baseball grandstand with multi-fixture men's and women's toilet rooms, a single-user family toilet room and drinking fountains. Features of accessibility were provided at the time of construction. *This is a good example of accessibility.*

Priority 3- Lower (or add) a coat hook at 48" maximum in the men's and women's accessible toilet stalls. *ADA 603.4*

Priority 3- Adjust the closer on the door to the family toilet room to reduce the amount of force needed to operate the door. *ADA 404.2.9*

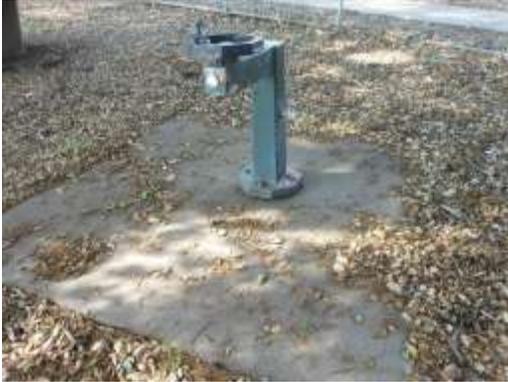
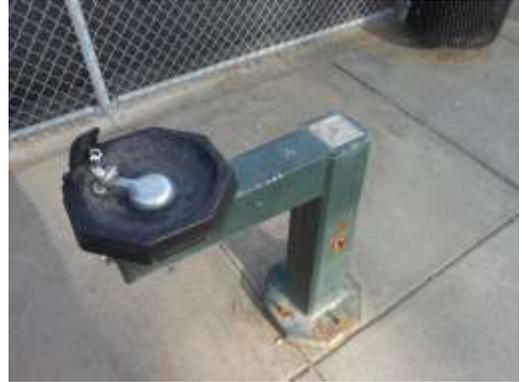
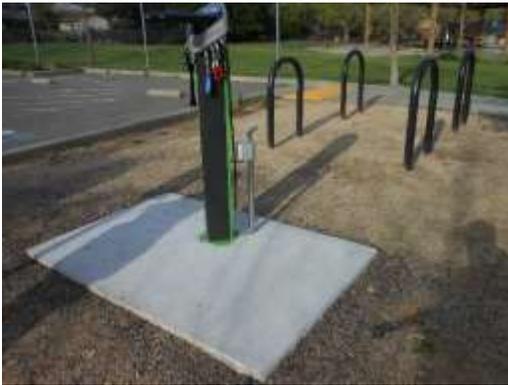
Drinking Fountains

Drinking fountains are located throughout the park. The 2 toilet room buildings provide dual height drinking fountains, including 1 that is wheelchair accessible and 1 that is standing height. *This is a good example of accessibility.*

Priority 2- Provide a standing height drinking fountain with a spout at 38"-43" AFF. *ADA 211.2, 602.7*

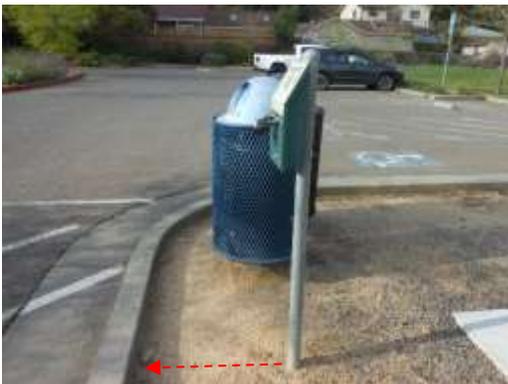
Bike Station

A bike repair station is provided near the parking lot. The station provides tools for individuals to make minor repairs to their bikes. All of the tools are located within reach range. *This is a good example of accessibility.*

Priority 3- Modify the compacted surface material to reduce the vertical change to ¼" maximum. *ADA 303.2*

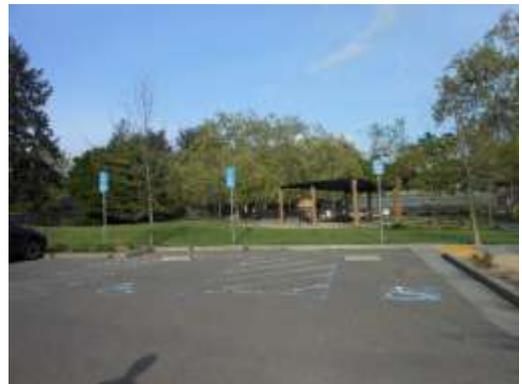
North

There are 3 spaces designated as accessible in the north parking lot. Each space has a sign and an adjacent access aisle (2 of the spaces share an 8' wide aisle, 1 of the spaces has a 5' wide aisle). *This is a good example of accessibility.*

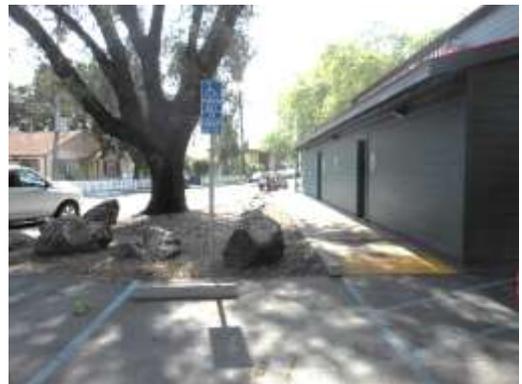
South

There is a small lot at the south end of the park near the baseball stadium. There is currently 1 space designated as accessible. *This is a good example of accessibility.*

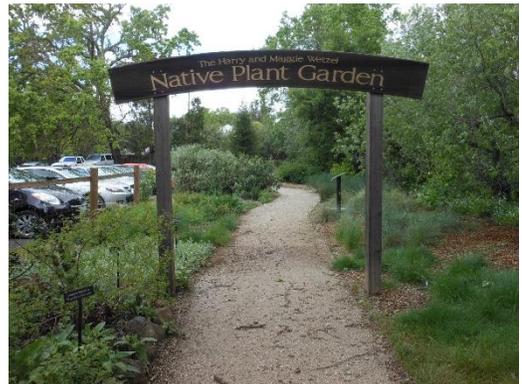
Route

A compacted aggregate surface path is provided through the center of the garden. *This is a good example of accessibility.*

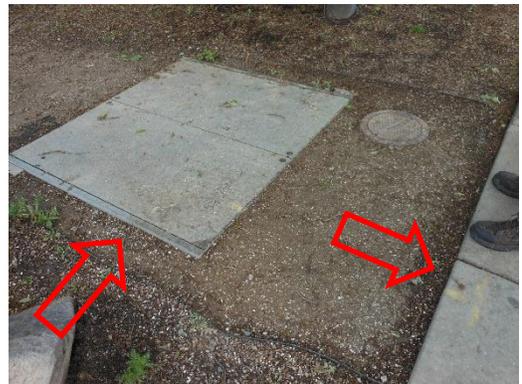
Transitions

At the entry to the garden there is an abrupt vertical rise where the surface material transitions from the concrete sidewalk to the compacted aggregate. There is also an abrupt rise where the route crosses over a utility cover.

Priority 3- Modify (add) aggregate surface material where it transitions between surface so the vertical rise does not exceed 1/4". ADA 303.2

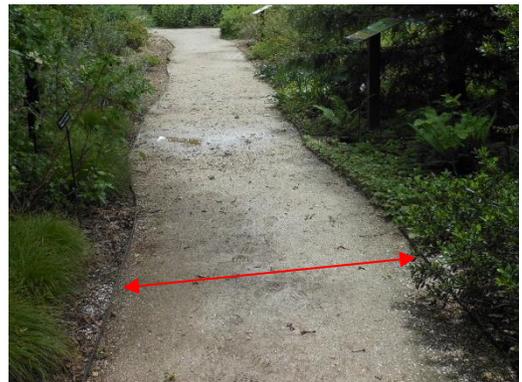
Width

The route through the garden is 5'-10" wide (metal edging defined the width of the route and contains the compacted aggregate surface material). *This is a good example of accessibility.*

Note: At 5'-10" wide the route is not wide enough to provide a turning space; a T-turn is provided where the route connects to the Cerri/Purity site.

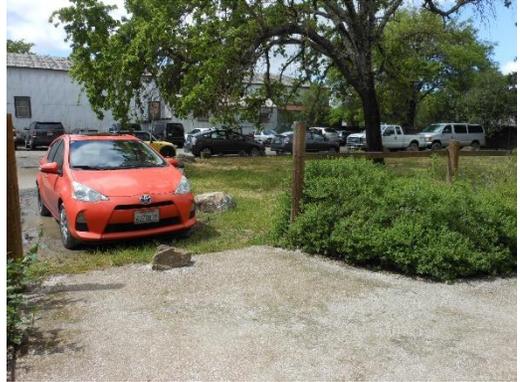
Route

There is a spur that connects the route through the garden to the Cerri/Purity site. The compacted aggregate route currently ends at the edge of the garden and leads to grass/gravel parking.

Priority 3- As the Cerri/Purity site is redeveloped, provide an accessible route to the connection.
ADA 206.2.1

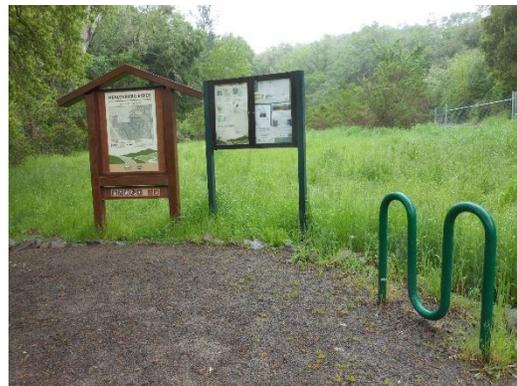
Trailhead

The trailhead provides information signage, maps and a bike rack. The maps have been positioned adjacent to the compacted surface. *This is a good example of accessibility.*

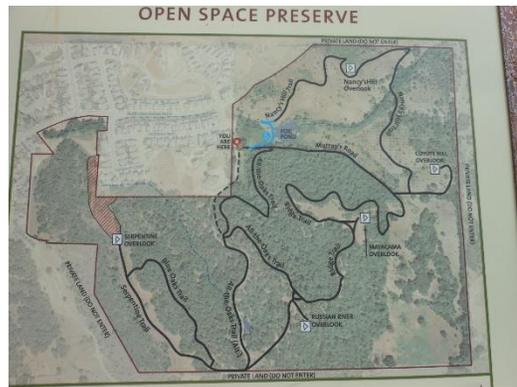
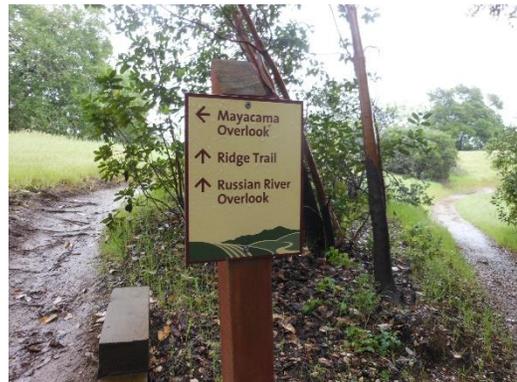
Signs

A large map has been provided at the trailhead as well as directional trailhead signs.

Priority 2- Provide additional information on the trailhead signage, including: length, surface type, typical & minimum width, typical & maximum slope and typical & maximum cross slope.

Recommended based on ABA 1017.10

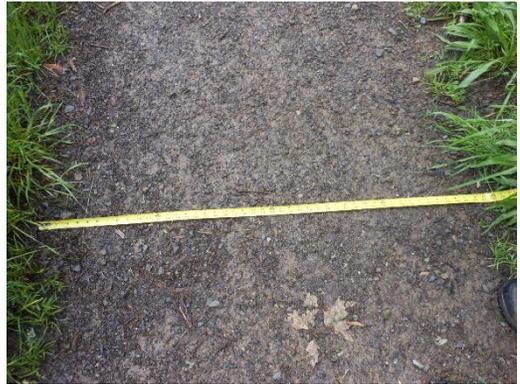
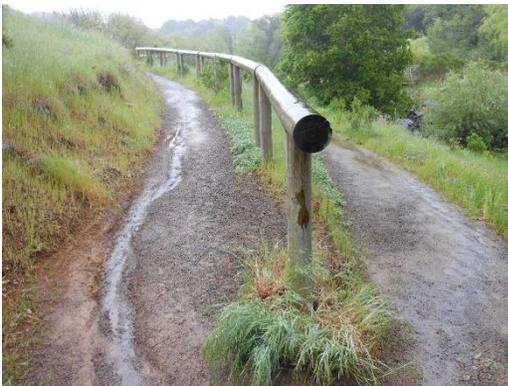
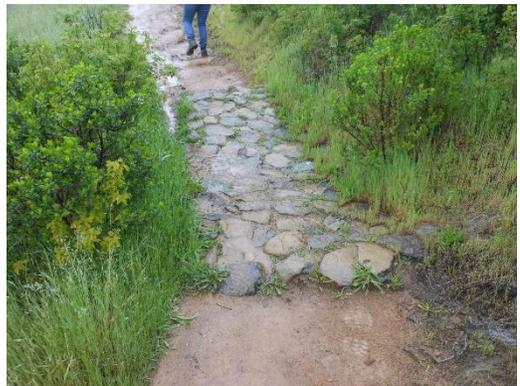
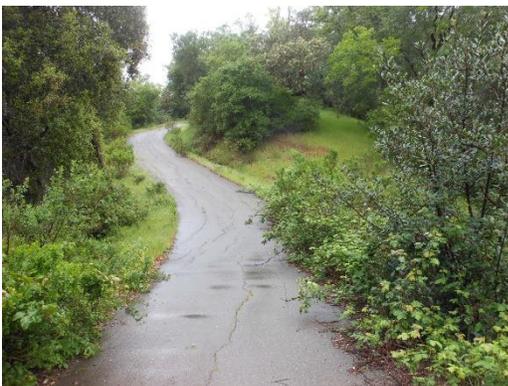
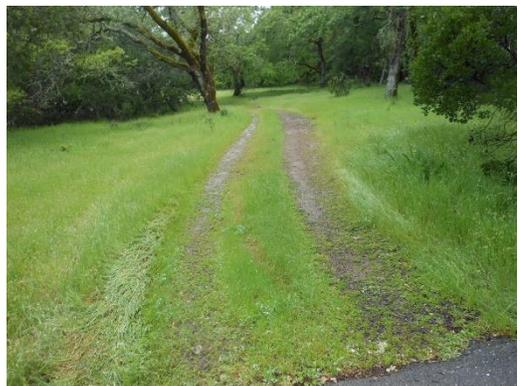
Bridges have been provided at locations where the trail crosses water. There are currently vertical rises greater than 1/2" and the openings at the entry to the bridges would allow passage of a 1/2" sphere.

Priority 3- Modify the surface material along the trail identified as accessible to reduce the vertical rise. *Recommended based on ABA 1017.5*

Priority 4- Modify the surface materials to reduce the vertical rise. *Recommended based on ABA 1017.5*

Priority 4- Modify the connections/transition at the entry to bridges so the opening does not exceed 1/2". *Recommended based on ABA 1017.6*
