*Accessibility Evaluation
for*

**City of Healdsburg, CA
Community Services and
Parks & Recreation Department**

2017

julee quarve-peterson, inc.

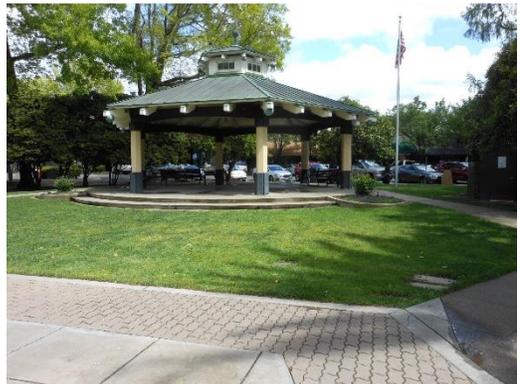
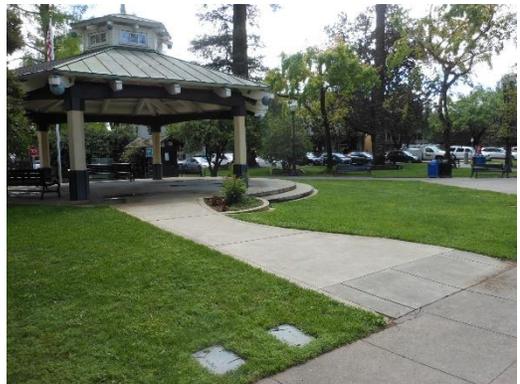
The utility/storage building serving the gazebo currently has knob style hardware at the entry door.

Priority 4- Replace the knob style hardware with an easily operable style that does not require tight grasping, pinching or twisting to operate. *ADA 404.2.7, 309*

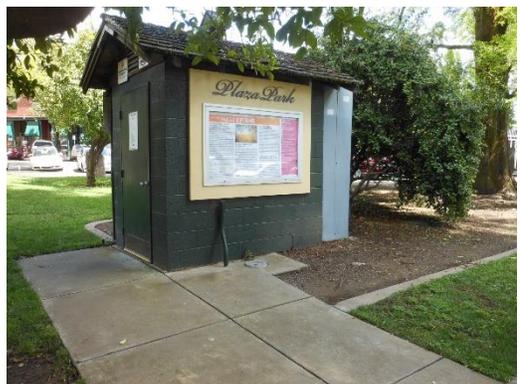
As an assembly area with audio amplification, an assistive listening system is required for events at the gazebo.

Priority 2- Provide an assistive listening system. ADA 219.2

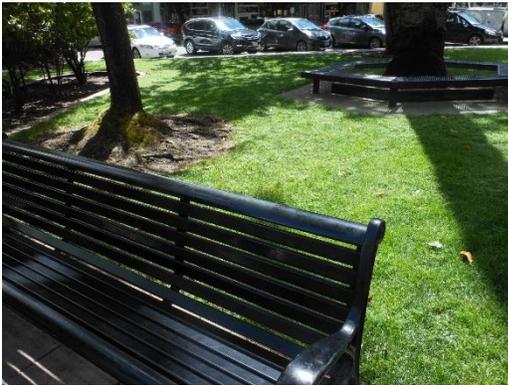
Benches have been provided throughout the park, including benches located along an accessible route and with adjacent space for a wheelchair. *This is a good example of accessibility.*

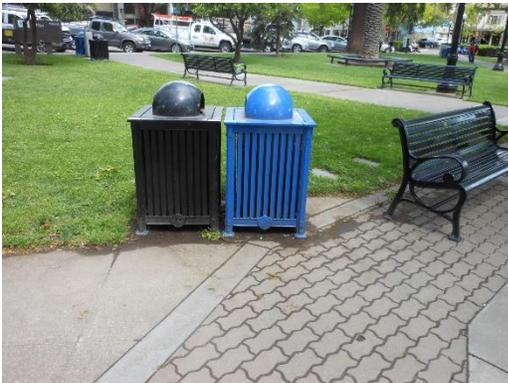
Trash receptacles are located throughout the park. They are typically located adjacent to the accessible route. *This is a good example of accessibility.*

Maintenance- Ensure that when trash is emptied/collected, the lid is positioned facing the accessible route so the opening is located within reach range. *ADA 308*

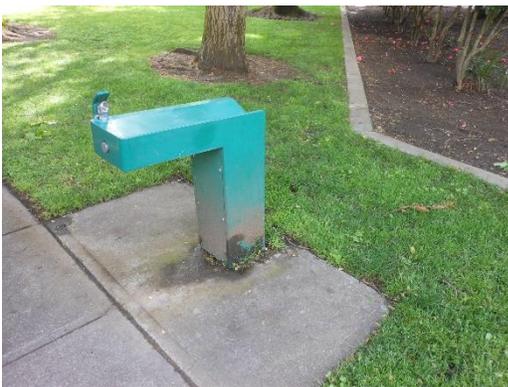
There is currently 1 drinking fountain provided on the site. The drinking fountain is located on an accessible route and provides a forward approach with knee and toe clearance. *This is a good example of accessibility.* A standing height drinking fountain is not currently provided.

Priority 2- Provide a standing height drinking fountain with a spout at 38"-43" AFF (a minimum of 2 drinking fountains are required at each site). *ADA 211.2, 602.7*

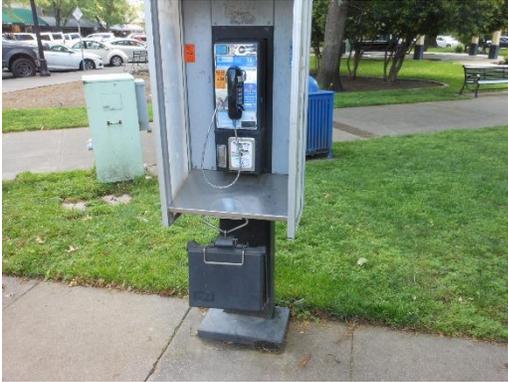
A pay phone is located near the corner of Plaza St. and Center St. The pay phone is positioned along an accessible route and provides a parallel clear ground space. *This is a good example of accessibility.* The phone is currently at 53" to the coin slot (highest operable part) and does not have volume control.

Priority 3- Replace the phone with a style that allows for volume control. *ADA 704.3*

Priority 4- Lower the phone (or replace with an alternate style) so the highest operable part is at 48" maximum. *ADA 308*

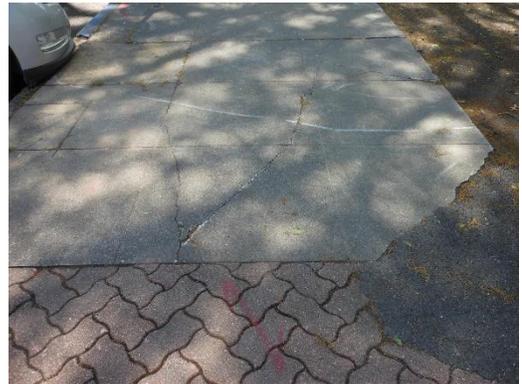
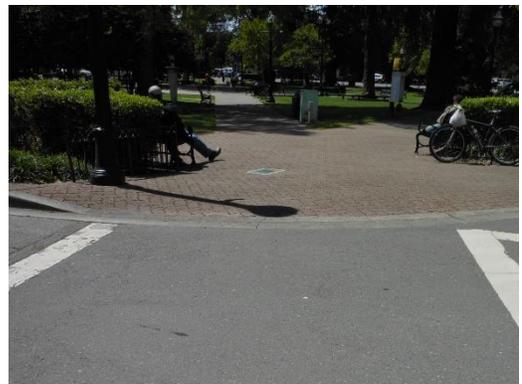
The tree roots have caused the sidewalks along the city streets to heave, creating cross slope of up to 7.4% (vs. 2% / 1:48 maximum).

Priority 2- Repair/raise the sections of sidewalk where cross slope exceeds 1:48. ADA 403.3

Note: This will be an ongoing maintenance issue unless the tree roots are addressed.

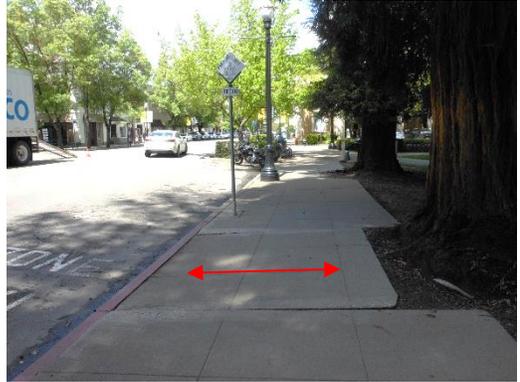
Sidewalks are provided from the perimeter to the fountain at the center of the park from the corners and mid-block. The slope of the sidewalks exceeds 5% (or 5%-8.33% if handrails are provided) at the following locations:

Priority 3- Reconstruct the routes to reduce the slope to less than 5%. ADA 403.3, 405, 405.8

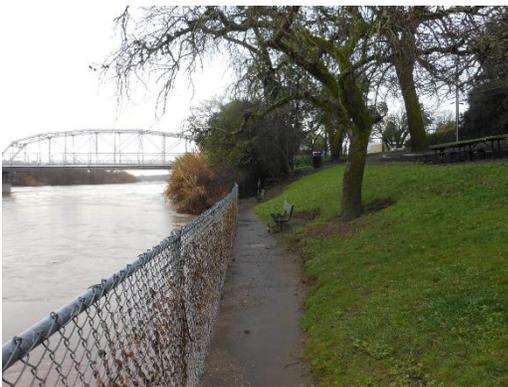
Based on signage, fishing in the river is allowed. There are no constructed features/amenities (such as fishing piers) provided for fishing; only a chain link fence that also serves as a safety barrier.

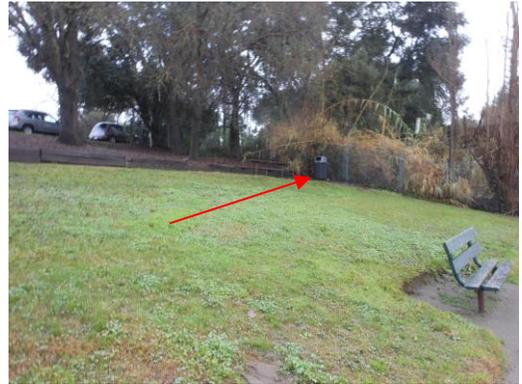
Three benches are located in the park, dispersed among the picnic tables. Currently none of the benches is located on an accessible route.

Priority 3- Provide a bench on an accessible route. *ADA 206.2.2*

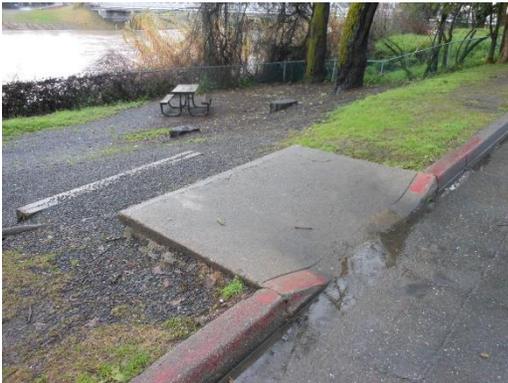
There is not currently an accessible route to the entry to the park. A curb cut is provided mid-block at the street, but it does not align with or connect to any other city sidewalks.

Priority 2- Create an accessible route to the park entry. *ADA 206.2.1*

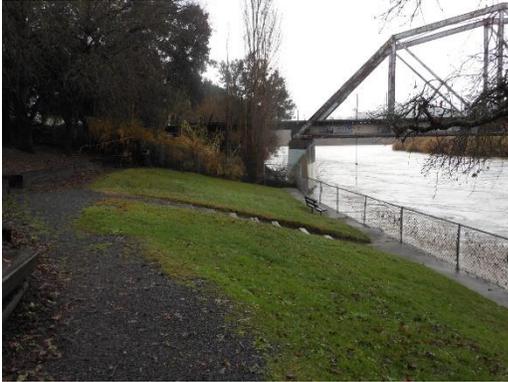
There is not currently an accessible route within the park, from the entry to any of the amenities or features. There are 21 stairs (railroad ties set into the hillside) from the street level down to the edge of the water.

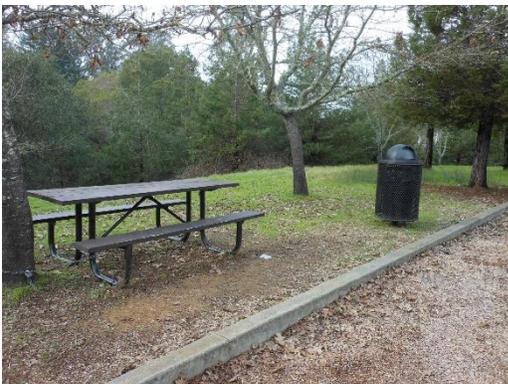
A picnic table is positioned adjacent to the defined play area. The picnic table is currently chained to a tree and located in the grass. An accessible route is not currently provided to the picnic table and the table style does not provide a forward approach.

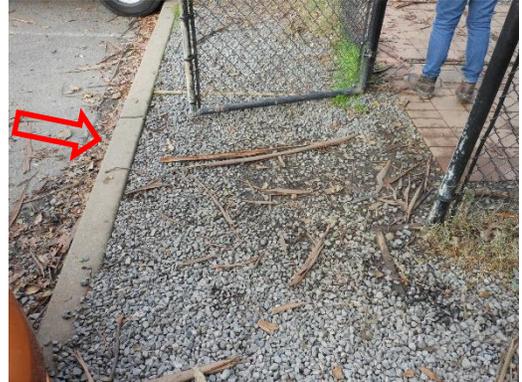
A gated vestibule is used at the entry to the dog park. Maneuvering clearance is not currently provided at the exterior gate. The latch hardware to operate the gates is currently at 60" AFF.

Priority 2- When creating the accessible route up to the entry of the dog park, incorporate providing maneuvering clearance at the exterior side of the gate. ADA Table 404.2.4.1

Priority 2- Replace the gate hardware (or lower the existing) with a style that can be operated from both sides of the gate at 48" maximum AFF. ADA 404.2.7

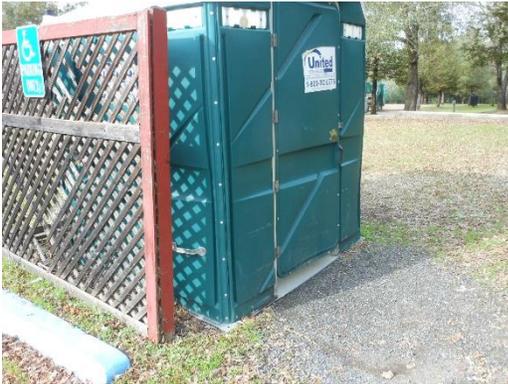
Portable Toilet

A portable toilet is located near the play area. The toilet is a larger/accessible style. *This is a good example of accessibility.*

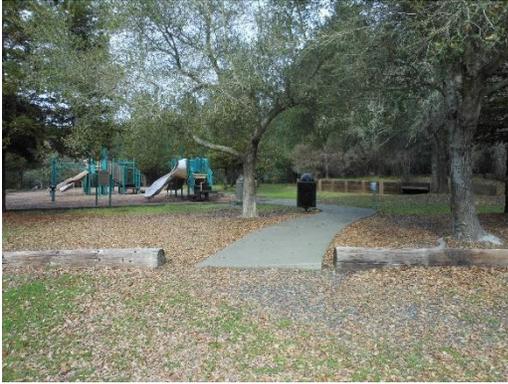
Play Area

There is not currently an accessible route from parking to the defined play area. A 60" wide concrete route is provided from a timber border at the edge of overflow parking up to the defined play area (including the drinking fountain and 1 trash receptacle), but the route does not connect to the accessible parking.

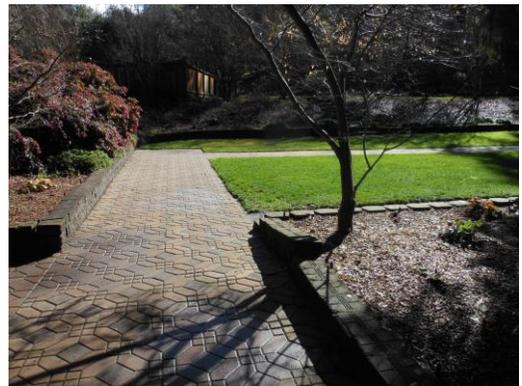
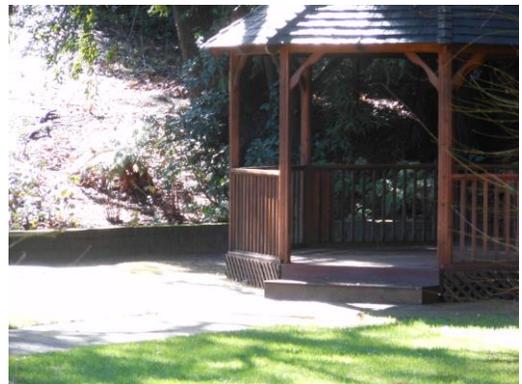
Event Space

There are 2 levels/tiers of event space- the lower tier has the gazebo and a paver patio area; the upper level has an open grass space. Stairs connect the lower and upper areas of the garden.

JQP, Inc. Recommends

Priority 4- Create an accessible route (ramp) between the upper and lower levels of the garden area. *ADA 206.2.4*

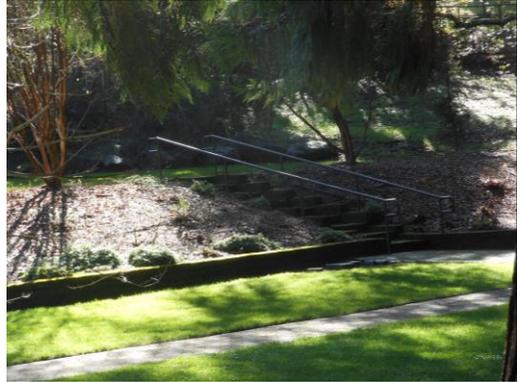
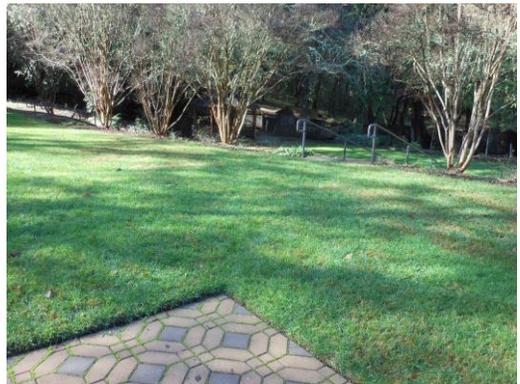
Accessible Route

The route to the north gate (lower level of garden area) currently has a slope of up to 9.2% (vs. 5% maximum or 8.33% if handrails provided).

Priority 2- Install handrails at the ramp. *ADA 405.8*

Priority 3- Reconstruct the route to reduce the slope to 8.33% maximum. *ADA 405.2*

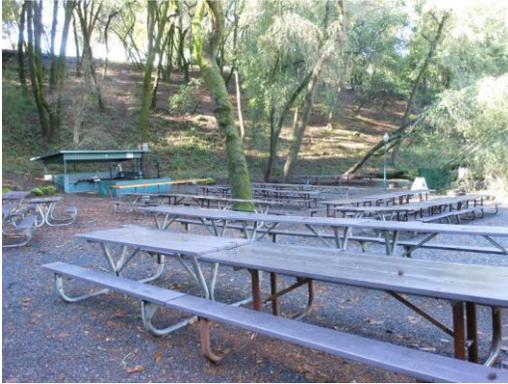
Picnic

There are 32 picnic tables located in the picnic area. Currently none of the picnic tables is located on an accessible route and only 1 of the tables provide a forward approach with knee and toe clearance.

Priority 2- Provide 13 picnic tables (approximately 5% of the seating positions) with a wheelchair position with a forward approach and located on an accessible route. *ADA 226.1, 902.2, 206.2.2*

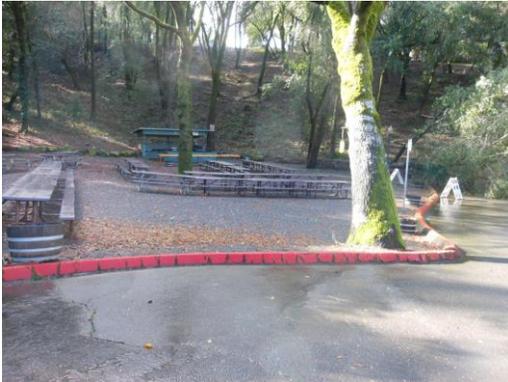
Site

The overall picnic area slopes at approximately 5%. Each of the accessible picnic tables with a forward approach also required a level (2% / 1:48 maximum slope) clear ground space.

Priority 4- Modify the surface within the picnic area to provide a level clear ground space for each of the accessible picnic tables.

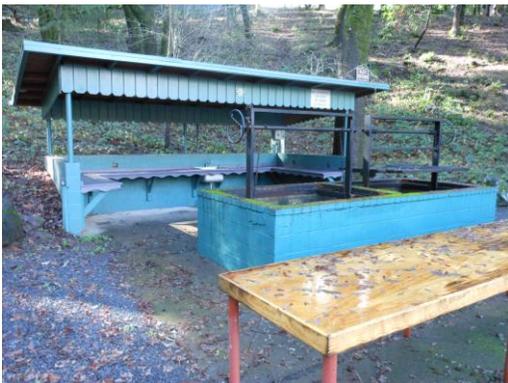
Service Counter

A serving counter is provided near the grills and prep area. The counter is at 33". *This is a good example of accessibility.*

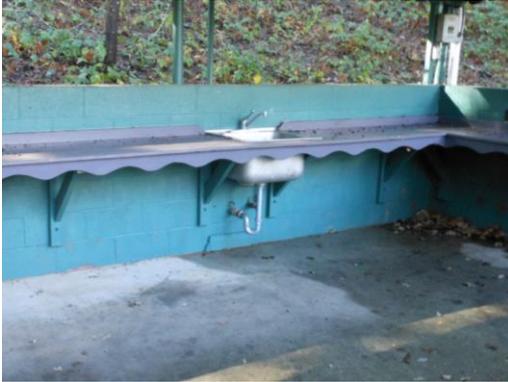
Sink

A sink is provided near the grills and prep area. The rim of the sink is at 34". The deep basin obstructs the knee clearance for a forward approach.

Priority 2- Provide an accessible sink with a forward approach (replace the existing sink or add an additional sink). *ADA 212.3, 606.2*

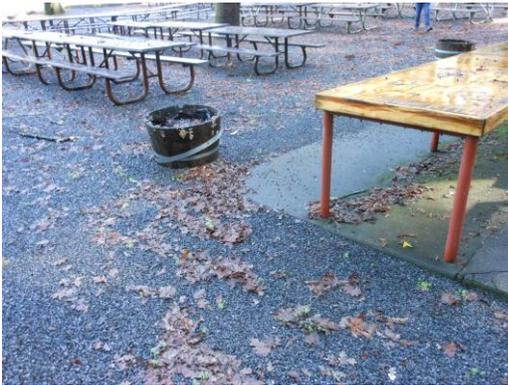
Surface Material

The surface material throughout the picnic area is a compacted gravel with a layer of loose gravel on top. A concrete pad is provided at the prep and serving area. There is currently a 3/4" rise between the loose gravel and the concrete pad.

Priority 3- Replace (or modify) the loose gravel surface material to provide a firm, stable, slip resistant surface. *ADA 302.1*

Priority 3- Modify the transition between the loose gravel and the concrete pad to reduce the vertical rise to 1/4" maximum (or 1/2" maximum if beveled at 1:2). *ADA 303.2*

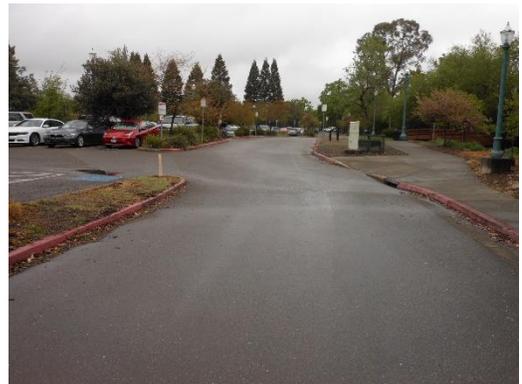
Location

Currently the 6 parking spaces designated as accessible are located in the south half of the parking lot (including 4 within an area otherwise reserved for valet). There are currently no accessible parking spaces associated with the north side of the lot, closest to the Cerri/Purity Building, City Hall and the Harry & Maggie Wetzel Native Plant Garden.

Priority 2- When designating additional accessible parking spaces, locate the new accessible parking spaces on the north end of the lot. *ADA 208.3.1*

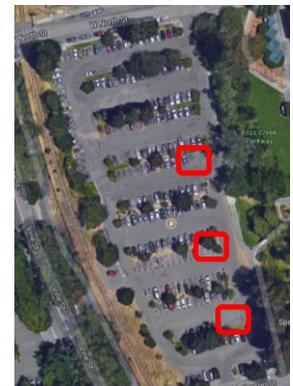
Signs

Of the 6 parking spaces designated as accessible, 2 of the spaces were missing signs at the time of site visit.

Priority 2- Replace the missing signs. *ADA 502.6*

Priority 4- In addition to replacing the missing signs, CA Accessibility Code requires painting the words "No Parking" on the surface of the parking space and outlining the accessible parking in blue.

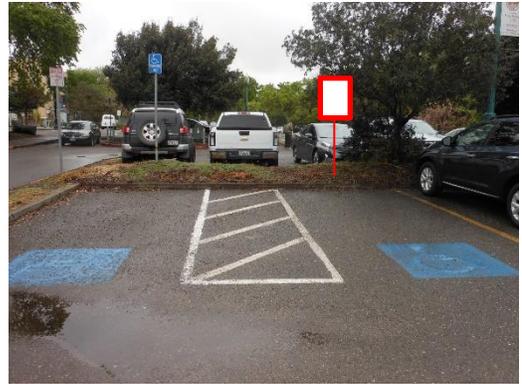
South

Surface Marking

Currently the 2 accessible parking spaces and aisle located furthest north in the lot have surface markings (aisle and space width stripes) that have faded/worn away to the point they are no longer visible.

Priority 3- Restripe the accessible parking spaces and aisle to clearly define the width of the parking space and discourage parking within the aisle.

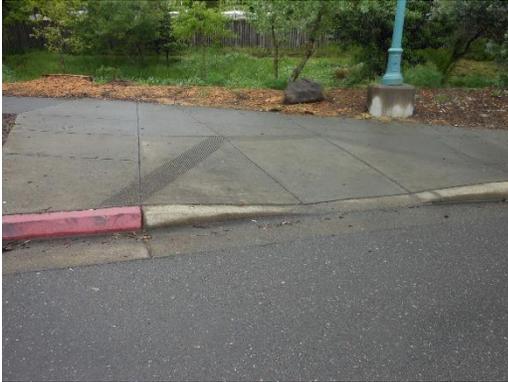
Curb Cut

The curb cut and route towards the bridge aligning with Plaza Street currently has a cross slope of up to 3.2% (vs. 2% / 1:48 maximum).

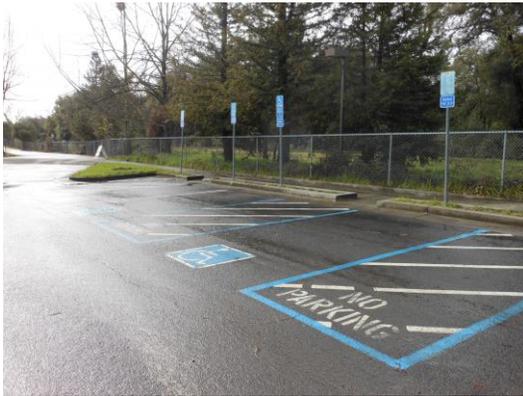
Photo 1: Accessible parking spaces have been designated near the main entry. *This is a good example of accessibility.* The slope within the parking spaces is up to 3.4% (vs. 2% maximum).

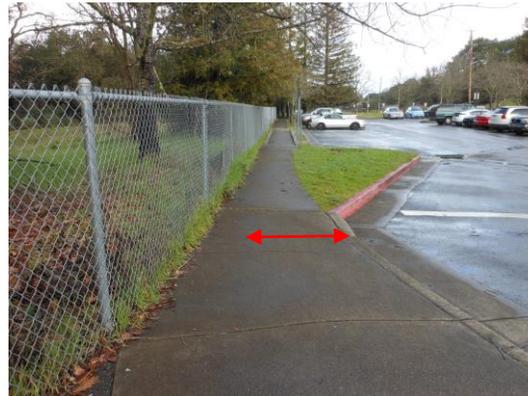
Photo 2: The accessible route from the parking to the main entry currently has up to 15% cross slope (vs. 2% maximum) where the route crosses the driveway apron for the service drive.

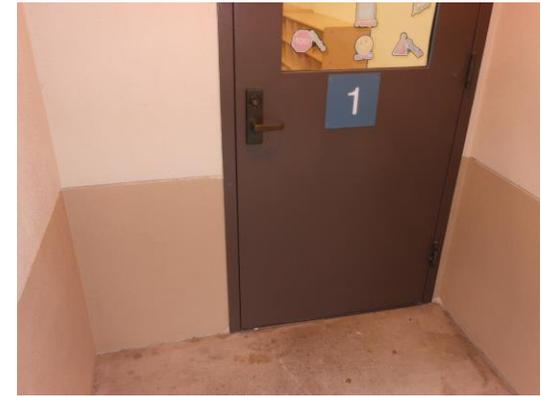
Photo 3: Typical classroom entries do not currently provide signs with raised and braille room numbers and the existing signs are mounted on the door (vs. adjacent to the latch side). Windows are provided in the doors with the bottom edge of the viewing glass at 46"-50" (vs. 43" maximum).

Location JQP # / Item #	Solution / Comments	Qty	Unit Cost	Total Cost	Priority	Estimated Compl. Date	Person Responsible	Actual Compl. Date	Actual Cost
Building Wide									
40B	20347	Provide compliant raised and Braille permanent room identification signage. ADA 216.2 <i>Photo 3.</i>	18	\$40	\$720	2			
Exterior Route- From Parking									
08C	20457	Modify walkway to provide a maximum 1:48 (2%) cross-slope. ADA 403.3 <i>The route from the parking to the main entry currently requires cross the driveway apron for the service drive to the west of the building. The driveway apron creates nearly 15% cross slope along the route. Photo 2.</i>	1	\$2,500	\$2,500	2			
Men's Toilet Room- Across from 11									
22A	20385	Install a sign displaying the International Symbol of Accessibility at such time toilet room is fully accessible. ADA 216.8	1	\$50	\$50	2			
22B	20384	Install signage with appropriate raised and Braille lettering. ADA 216.2 <i>The existing sign does not include tactile or braille characters and is mounted on the door.</i>	1	\$40	\$40	2

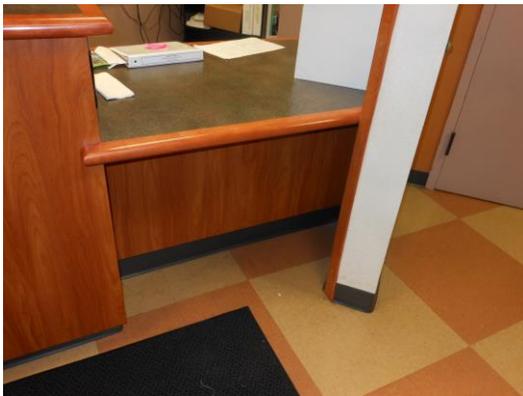
Photo 4: A forward approach is provided at the counter in the main office. *This is a good example of accessibility.* The overhang of the counter at the forward approach is currently 14 ¼" deep (vs. 17"-25").

Main Office									
21C2	20449	Modify the section of counter with a forward approach to provide compliant toe clearance that is 30" wide minimum and extends 17"-25" below the counter. ADA 904.4.2 <i>The front counter has been modified to provide a section with a forward approach. This is a good example of accessibility. Currently the accessible section of counter provides 14 1/4" of toe clearance (vs. 17"-25"). Photo 4.</i>	1	\$1,000	\$1,000	3			
Main Office- Corridor									
20B0	20450	Install a power door opener to address non-compliant maneuvering clearance at the door. ADA 404.2.4 <i>The secure corridor door separating the lobby from the private offices does not currently provide maneuvering clearance on the push or pull side of the door. It currently provides 10" (vs. 18" minimum on the pull side and 12" minimum on the push side).</i>	1	\$2,000	\$2,000	3

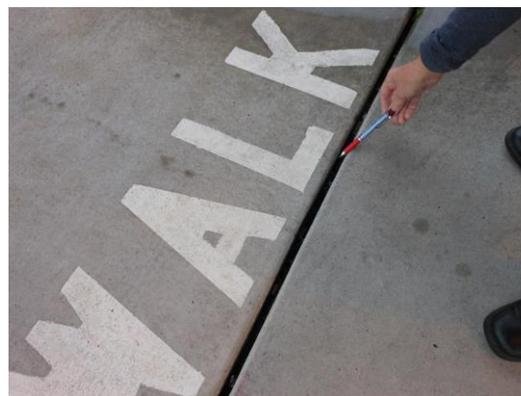
Photo 5: The classrooms are entered from an exterior corridor. Currently there are spaces between the sections of concrete that are greater than ½".

Location	Solution / Comments	Qty	Unit Cost	Total Cost	Priority	Estimated Compl. Date	Person Responsible	Actual Compl. Date	Actual Cost
JQP # / Item #									
Route- Adjacent to Classroom 2									
08E 20346	Eliminate openings in the ground surface that are greater than 1/2". ADA 302.3 <i>Photo 5.</i>	5	\$50	\$250	3				
Route- Adjacent to Classroom 4									
08E 20421	Eliminate openings in the ground surface that are greater than 1/2". ADA 302.3	5	\$50	\$250	3				
Route- Adjacent to Classroom 8									
08E 20411	Eliminate openings in the ground surface that are greater than 1/2". ADA 302.3	5	\$50	\$250	3

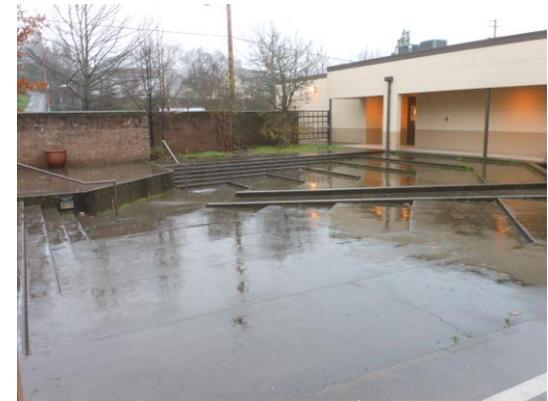
Photo 6: An outdoor amphitheater is provided near the assembly room. The performance area is currently located on an accessible route and a ramp is provided to the recessed seating bowl. The bottom of the seating area is not large enough to provide an integrated wheelchair viewing position with adjacent companion seating.

Location JQP # / Item #	Solution / Comments	Qty	Unit Cost	Total Cost	Priority	Estimated Compl. Date	Person Responsible	Actual Compl. Date	Actual Cost
Amphitheater									
09A 20344	Provide fully compliant handrails on both sides of the sloped surface of the ramp. ADA 405.8 <i>A ramp is provided to the lowest seating level in the outdoor amphitheater. Handrails are not currently provided on the ramp. Photo 6.</i>	50	\$25	\$1,250	3				
26D1 20345	Identify accessible viewing positions. ADA 221, Table 221.2.1.1 <i>There is not currently space for an integrated wheelchair at the base of the amphitheater seating area. Photo 6.</i>	1	\$0	\$0	3				
Assembly Room									
25E.1 20341	Provide a table with a forward approach including knee and toe clearance below- 30" wide minimum, 27" high knee clearance and 9" high toe clearance that extends 17"-25". ADA 902 <i>The structural supports for the movable tables currently obstruct the knee and toe clearance.</i>	1	\$200	\$200	3

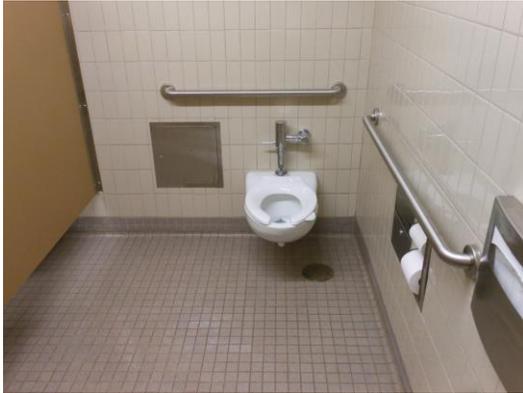
Photo 7: Multi-fixture toilet rooms throughout the building have been remodeled to provide features of accessibility. *This is a good example of accessibility.*

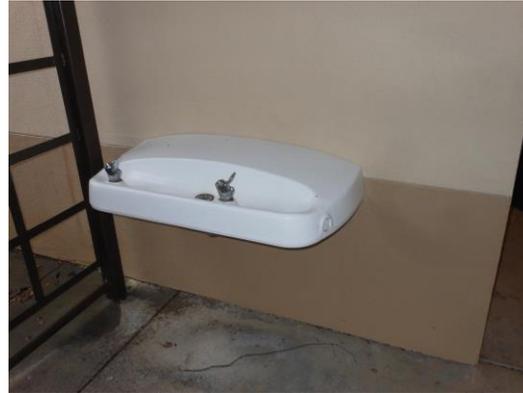
Photo 8: Drinking fountains are provided throughout the building. Currently all of the drinking fountains have spouts at 34"; there are no drinking fountains with spouts 38"-43".

Location	Solution / Comments	Qty	Unit Cost	Total Cost	Priority	Estimated Compl. Date	Person Responsible	Actual Compl. Date	Actual Cost
JQP # / Item #									
Drinking Fountains									
41A1	20455	Provide a minimum of one drinking fountain that has a 36" spout height with knee and toe clearance accessible for persons using wheelchairs (low) and one standard height (high) drinking fountain with a spout height 38" minimum and 43" maximum for persons who have difficulty bending or stooping. ADA 211.2, 602.4, 602.7 <i>Currently all of the drinking fountains have spouts at 34". There are no drinking fountains with spouts between 38"-43". Photo 8.</i>	1	\$1,500	\$1,500	3			
Exit Gate- Adjacent to 16									
12B	20441	Relocate door and frame to provide a compliant maneuvering clearance at the door. ADA 404.2.4 <i>Maneuvering clearance is not currently provided on the push side of the exit gate. This gate serves as an private / discreet entry to the clinic located in 15 and 16.</i>	1	\$1,500	\$1,500	3

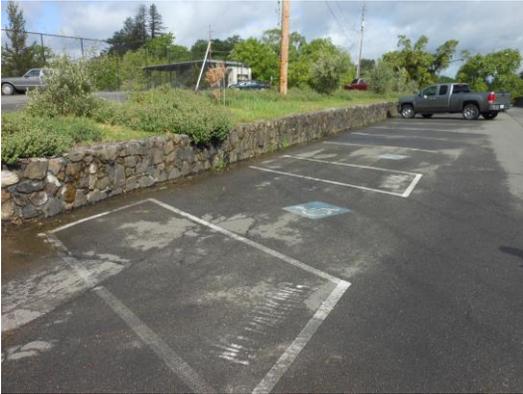
Photo 1: There are currently 2 parking spaces designated as accessible near the clubhouse. The aisles are not currently striped to discourage parking and they do not have upright signs. A total of 3 spaces have been designated as accessible in the lot; a minimum of 4 are required.

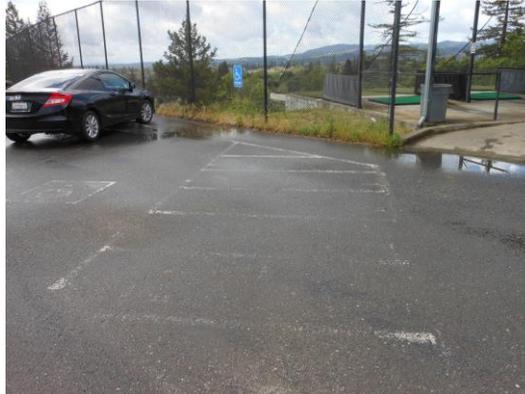
Photo 2: One accessible parking space has been designated near the practice range. *This is a good example of accessibility.* The sign is currently at 36" AFF (vs. 60" minimum).

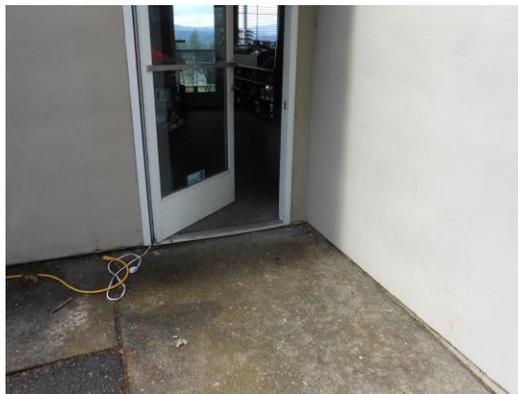
Photo 5: The retail/pro-shop entry has a door that swings both directions.

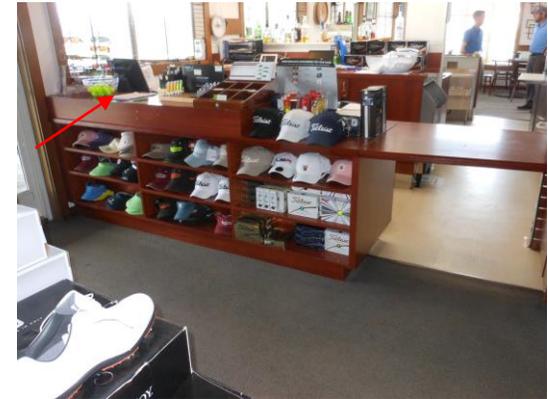
Photo 6: The retail/pro-shop counter currently provides a low section, however it is currently covered by a product display. It is also not where the transaction typically occurs.

Location JQP # / Item #	Solution / Comments	Qty	Unit Cost	Total Cost	Priority	Estimated Compl. Date	Person Responsible	Actual Compl. Date	Actual Cost
Clubhouse- Patio									
12H 20478	Bevel / replace / reset threshold so there is no abrupt rise greater than 1/2". ADA 404.2.5 <i>There is currently a 2" rise from the patio to the concession entrance.</i>	1	\$200	\$200	3				
12H 20479	Bevel / replace / reset threshold so there is no abrupt rise greater than 1/2". ADA 404.2.5 <i>There is currently a 2" rise from the patio to the pro-shop entrance.</i>	1	\$200	\$200	3				
				<i>Location Subtotal:</i>					\$400
Clubhouse- Pro Shop									
21A1 20503	Lower a minimum 36" wide section of counter to a maximum height of 36" above the floor. ADA 904.4.1 <i>The counter is currently at 40". An accessible section of counter has been provided, however it is not where the transaction typically occurs. Photo 6.</i>	1	\$1,000	\$1,000	3

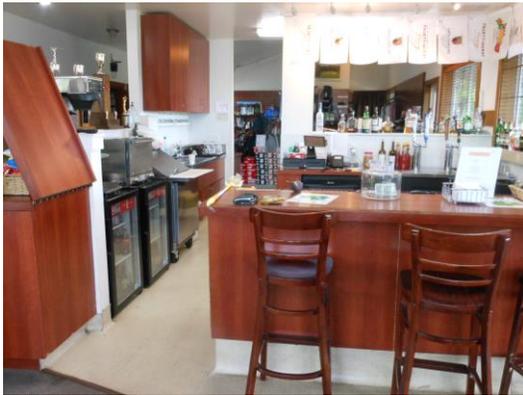
Photo 7: The counter at the concessions/food service is currently at 41 ¾" (vs. 34" maximum). Seating is also provided at the bar, but accessible seating is not available.

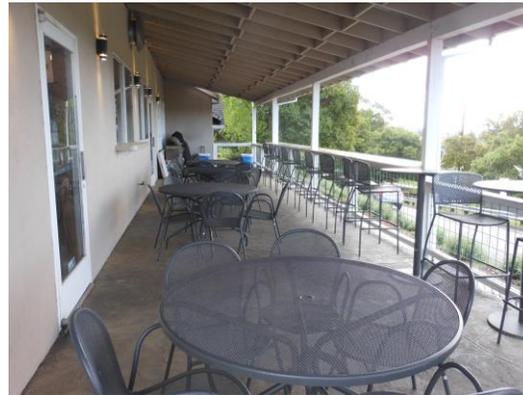
Photo 8: The patio provides additional seating areas; currently there are high-top positions at the drink rail as well as low tables. The base of the tables currently obstructs the knee and toe clearance for a forward approach.

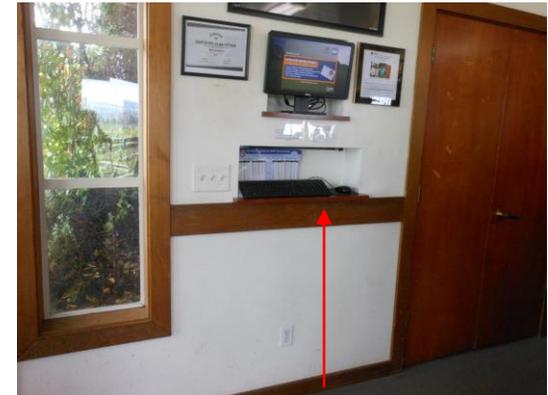
Photo 9: A computer for patrons to entry the scores is provided within the clubhouse. Currently the keyboard is at 43" (vs. 34" maximum).

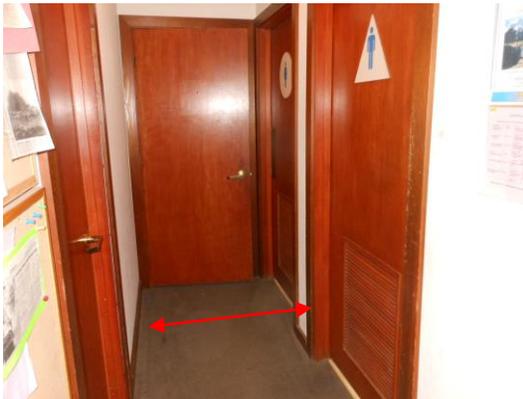
Photo 10: The corridor leading to the men's and women's toilet rooms provides 39 ½" depth on the push side of the door (vs. 48" minimum).

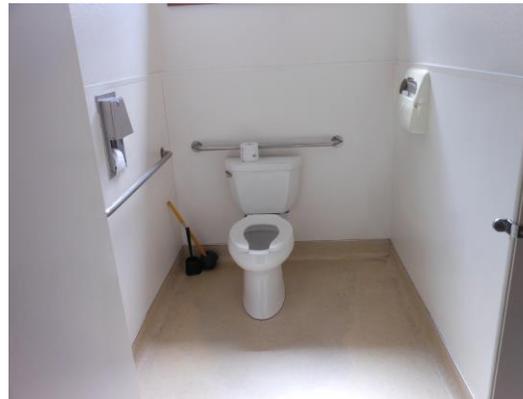
Photo 11: Modifications have been made within the toilet rooms to provide features of accessibility. *This is a good example of accessibility.* The stall in the men's toilet room is currently 57" wide (vs. 60" minimum) and the toilet is centered at 24" from the sidewall (vs. 16"-18").

Location JQP # / Item #	Solution / Comments	Qty	Unit Cost	Total Cost	Priority	Estimated Compl. Date	Person Responsible	Actual Compl. Date	Actual Cost
Clubhouse- Patio									
25E.1 20477	Provide a table with a forward approach including knee and toe clearance below- 30" wide minimum, 27" high knee clearance and 9" high toe clearance that extends 17"-25". ADA 902 <i>Seating for dining is provided on the patio at a drink rail (9 seats), high-top tables (3) and standard tables (4). The standard tables do not currently provide a forward approach with knee and toe clearance; it is obstructed by the base. Photo 8.</i>	1	\$200	\$200	2				
Men's Toilet Room- Clubhouse									
22H1 20497	Provide staple style pulls on both sides of the accessible stall door near the latch. ADA 604.8.1.2	1	\$50	\$50	2				
22M1 20499	Relocate the water closet so it is centered 16"-18" from the side wall or partition. ADA 604.2 <i>Currently at 24". Photo 11.</i>	1	\$1,600	\$1,600	2

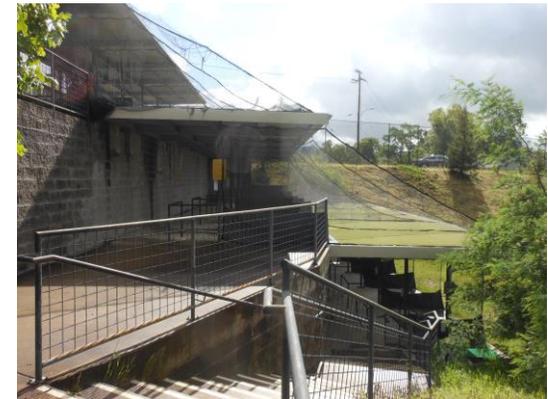
Photo 12: A 3-level practice range is provided. Currently there is an accessible route to the upper level, but not the lower 2 levels. Rules state that only irons can be used on the top level, while woods and irons can be used on the lower 2 levels.

Location JQP # / Item #	Solution / Comments	Qty	Unit Cost	Total Cost	Priority	Estimated Compl. Date	Person Responsible	Actual Compl. Date	Actual Cost
Practice Facility									
14D2 20505	Relocate program as necessary to an accessible location to provide program access. ADA 206.2.3 <i>The practice facility is 3 levels. An accessible route is provided to the top level, the route to the lower 2 levels requires stairs. Signs indicate the top level is only for irons; the lower 2 levels allow for use of irons and woods. Ensure policies allow individuals who are unable to use the stairs to reach the lower 2 levels are allows to use woods from the top level. Photo 12.</i>	1	\$0	\$0	1				
				Priority # 1 Total	\$0

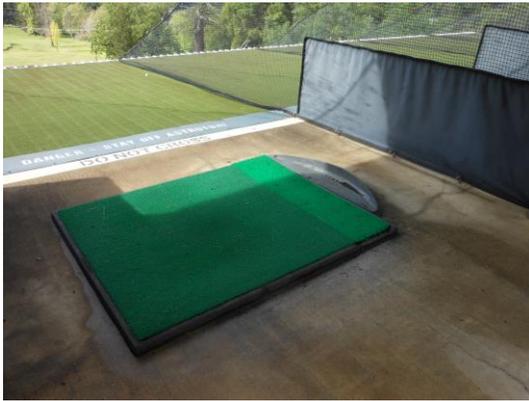
Photo 13: The teeing platform for the practice range is currently raised; there is not an accessible route onto any of the platforms.

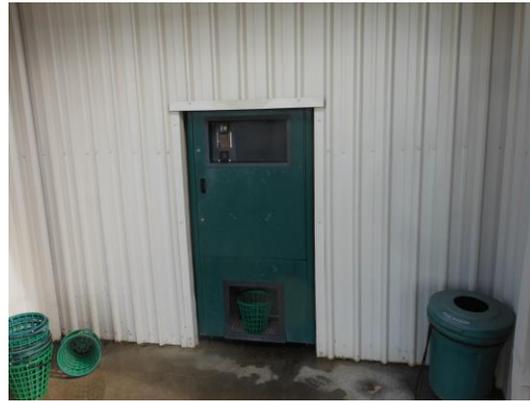
Photo 14: A self-serve ball dispenser is provided for the practice facility. Currently the coin slot is above the maximum reach at 54" (vs. 48" maximum) and the bucket dispenser is below the minimum reach at 12" (vs. 15" minimum).

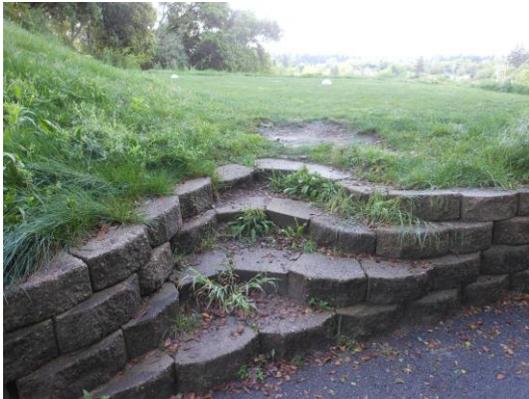
Photo 16: There are 3 holes (1, 3 and 7) where there is not a route to at least 2 of the teeing grounds.

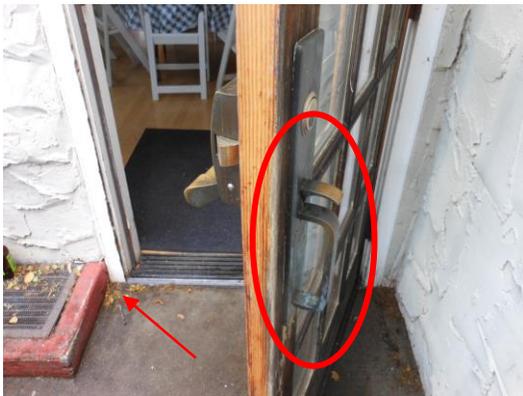
Photo 4: The rear building entry is on grade (it enters into the same room as the main entry). The hardware is currently a thumb-latch style that requires pinching to operate. In addition the grate adjacent to the door obstructs the clearance on the pull side.

Location JQP # / Item #	Solution / Comments	Qty	Unit Cost	Total Cost	Priority	Estimated Compl. Date	Person Responsible	Actual Compl. Date	Actual Cost
Back Entry (Accessible)									
12C3 20461	Remove or alter the permanent obstruction to provide maneuvering clearance at the exterior door. ADA 404.2.4 <i>The grate currently obstructs maneuvering clearance on the pull (exterior) side of the door. Photo 4.</i>	1	\$5,000	\$5,000	3				
20D 20460	Provide door hardware that does not require grasping, pinching or twisting to operate, such as lever. ADA 404.2.7 <i>The hardware on the back entry is currently thumb-latch style. Photo 4.</i>	1	\$250	\$250	3				
				<i>Location Subtotal:</i>					\$5,250
Bar									
21A1 20464	Lower a minimum 36" wide section of counter to a maximum height of 36" above the floor. ADA 904.4.1 <i>The bar top is currently at 44". At the time of site visit the bar was positioned on casters; if the casters were removed the bar would be at 36". Photo 6.</i>	1	\$1,000	\$1,000	3

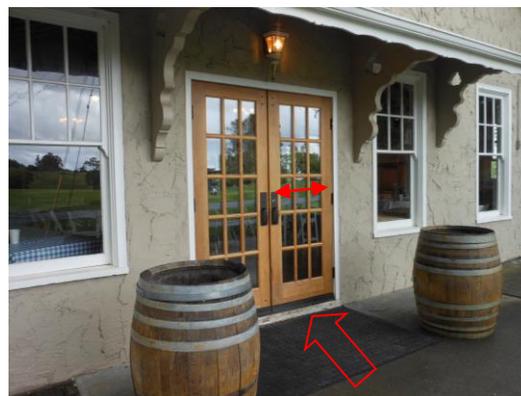
Photo 5: The main entry doors open on to a patio space that is used for functions. A single leaf of the double doors currently provides a 28" clear opening (vs. 32" minimum) and there is a 4" rise at the threshold.

Front Entry (to Patio)									
12A1 20462	Widen at least one leaf of the double entrance doors to provide a minimum 32" clear opening. ADA 404.2.2, 402.2.3 <i>A single leaf currently provides a 28" clear opening. (The patio is used as event space.) Photo 5.</i>	1	\$1,500	\$1,500	3				
Kitchen- Service Window									
21A1 20473	Lower a minimum 36" wide section of counter to a maximum height of 36" above the floor. ADA 904.4.1 <i>The service window/counter from the commercial/catering kitchen is currently at 37 3/4".</i>	1	\$1,000	\$1,000	3

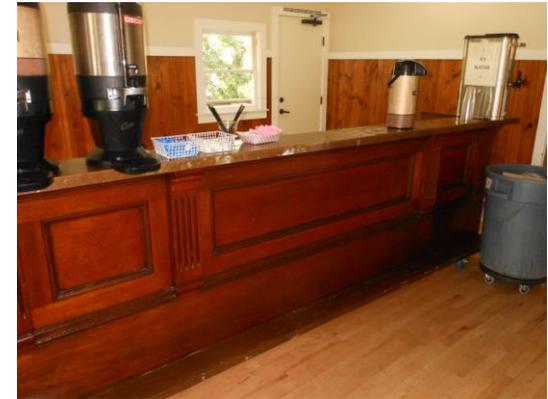
Photo 6: A bar is provided for events in the rental building. At the time of site visit the bar was positioned on casters, raising the counter height to 44" (vs. 34" maximum).

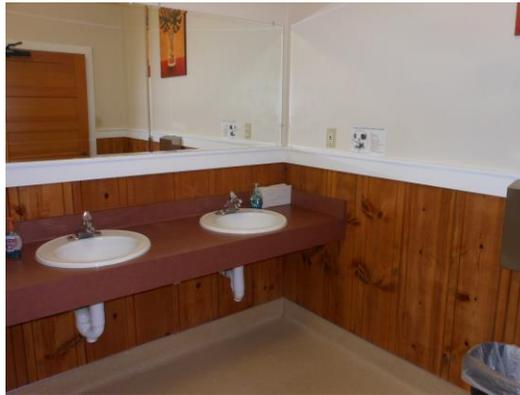
Photo 8: The mirror is currently at 49" (vs. 40" maximum).

08D1	20474 Modify / replace existing surface material to eliminate changes in level greater than 1/2". ADA 303.2 <i>The tree root system has damaged the asphalt route to the building entry, creating vertical rises greater than 1/4". Cost already calculated when addressing slope.</i>	1	\$0	\$0	3				
Women's Toilet Room									
22H1	20466 Provide staple style pulls on both sides of the accessible stall door near the latch. ADA 604.8.1.2	1	\$50	\$50	3				
22V	20465 Install a full-height mirror or provide a mirror where the bottom of the reflective surface is at 40" maximum above the floor (when mounted above a lavatory or counter) or 35" maximum (when not mounted above a lavatory or counter). ADA 603.3 <i>Currently at 49". Photo 8.</i>	1	\$300	\$300	3				
				<i>Location Subtotal:</i>					\$350
				Priority # 3 Total					\$13,500

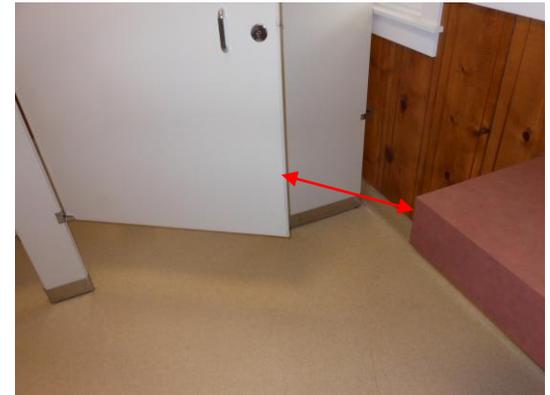
Photo 9: In the men's toilet room maneuvering clearance is not currently provided at the door to the accessible stall because of the vanity countertop. If the door were hinged on the opposite side additional maneuvering clearance would be provided.

Location JQP # / Item #	Solution / Comments	Qty	Unit Cost	Total Cost	Priority	Estimated Compl. Date	Person Responsible	Actual Compl. Date	Actual Cost
Men's Toilet Room									
22-20B1 20468	Remove / relocate / replace moveable object to provide needed maneuvering clearance on the pull side of the door. ADA 404.2.4 <i>The urinal privacy screen reduces clearance on the pull side of the door to 17" (vs. 18" minimum).</i>	1	\$50	\$50	4				
221 20472	Re-hinge the stall door at the accessible stall in order to provide maneuvering clearance at the stall door. ADA 604.8.1.2, 404.2.4 <i>Maneuvering clearance is not currently provided on the pull side of the accessible stall door; it is obstructed by the vanity. Hinge the door on the other side to provide maneuvering clearance. Photo 9.</i>	1	\$75	\$75	4				
				<i>Location Subtotal:</i>					\$125
Women's Toilet Room									
22-20G 20467	Adjust door closer to provide a maximum 5 pounds opening force. ADA 404.2.9 <i>Currently requires 8 pounds of force to open.</i>	1	\$50	\$50	4

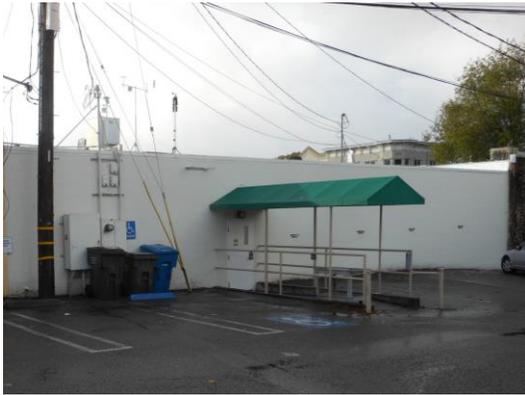
Photo 1: There is currently 1 parking space designated as accessible. The parking space does not currently provide an adjacent aisle.

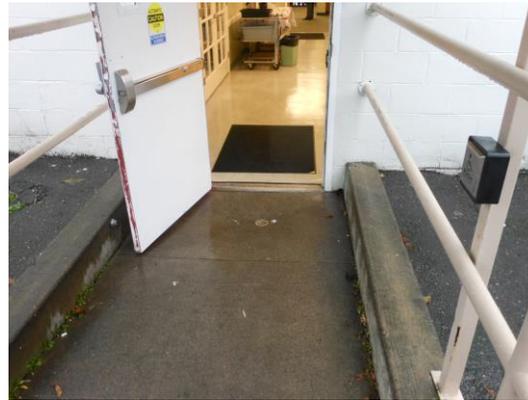
Photo 2: The back entry to the senior center (closest to the parking) does not currently provide maneuvering clearance at the door. A power operated door has been added to address the lack of maneuvering clearance.

12B1.1 20329	Modify the slope of the area necessary for maneuvering clearance to ensure there is no slope greater than 2% (1:48) in any direction. ADA 404.2.4.4 <i>The slope within the maneuvering clearance at the exterior side of the door is currently up to 12.1%. A power door opener has been provided. Photo 2.</i>	1	\$2,000	\$2,000	3				
				<i>Location Subtotal:</i>					\$3,000
Retail									
14C 20318	Bevel abrupt rise between 1/4" and 1/2" with a maximum slope of 1:2, and bevel/ramp abrupt rises greater than 1/2" with a maximum slope of 1:12 (8.33%). ADA 303.3 <i>There is currently a 1" rise at the threshold of the sliding doors to the retail area. Photo 5.</i>	5	\$100	\$500	3				
				Priority # 3 Total					\$7,970

Rear Entry (Parking)									
12C	20330	Relocate door and frame to provide a compliant maneuvering clearance at the door. ADA 404.2.4 <i>Maneuvering clearance is not currently provided beyond the latch on the pull side of the door. A power door opener has currently been provided. Photo 2.</i>	1	\$1,500	\$1,500	4			
20P	20328	Lower the window in the door (or the sidelite) so the bottom is at 43" maximum. ADA 404.2.11 <i>Currently at 53".</i>	1	\$250	\$250	4			
				<i>Location Subtotal:</i>		\$1,750			
					Priority # 4 Total		\$3,675

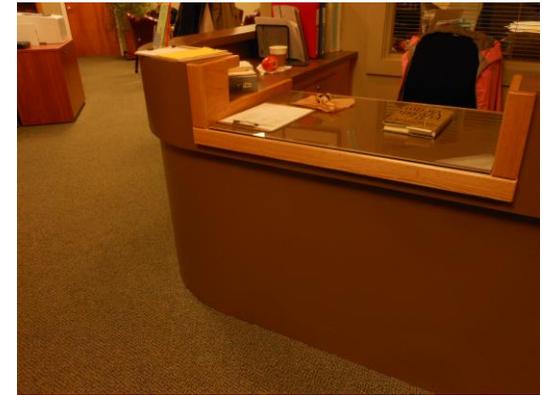
Photo 3: The front counter has been modified to provide an accessible section at 34" AFF. *This is a good example of accessibility.* The accessible section is currently 34" wide (vs. 36" minimum).

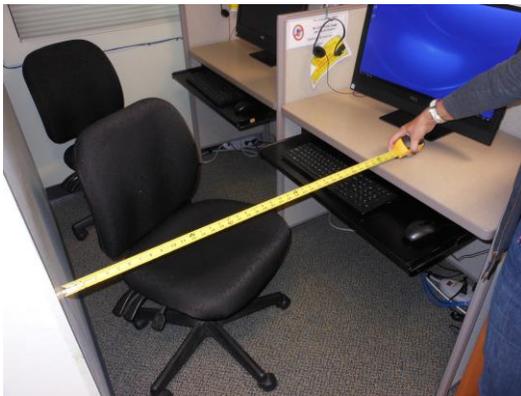
Photo 4: There are 4 computers provided for public use. The keyboard tray reduces the knee clearance to 25" (vs. 27" minimum). The computers are currently positioned so close to the wall that there is not adequate space for a wheelchair to use a forward approach.

Location JQP # / Item #	Solution / Comments	Qty	Unit Cost	Total Cost	Priority	Estimated Compl. Date	Person Responsible	Actual Compl. Date	Actual Cost
Computers									
29A 20319	<p>Provide a minimum of one computer station on an accessible table / counter that provides a forward approach with knee and toe clearance. The top height of the surface is to be 28"-34" above the floor, with knee clearance a minimum 27" high by 30" wide x 19" deep. ADA 902.2</p> <p><i>There are 4 public use computers at the Senior Center. The keyboard tray reduces the knee clearance at the computers to 25" (vs. 27" minimum). The arrangement of the 4 computers currently makes the route to the computers really tight- a wheelchair positioned at 1 computer would obstruct the route to other computers. Consider removing 1 (or more) computers to increase the circulation space in the area- conversations with staff indicate all 4 computers are rarely used at the same time. Photo 4.</i></p>	1	\$200	\$200	2

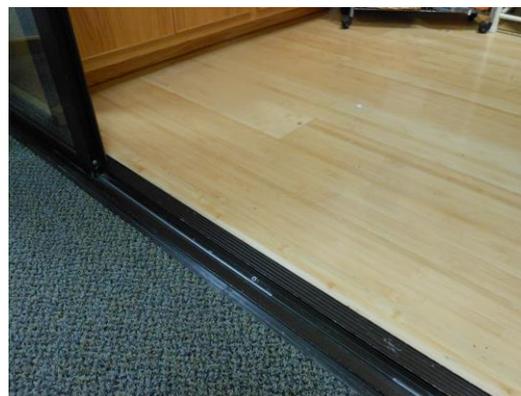
Photo 5: A retail area is provided near the lobby. Sliding glass doors are opened when the retail shop is open; the track for the sliding doors currently creates a 1" rise at the threshold.

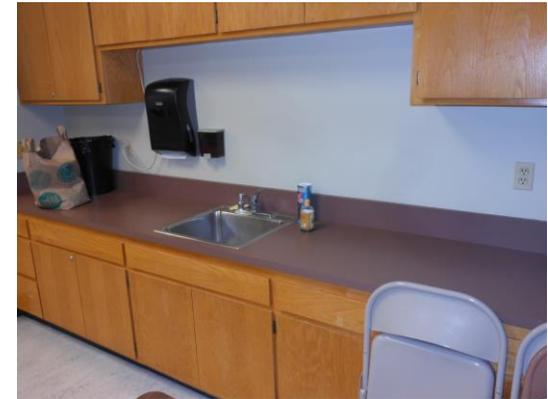
Photo 6: A sink is provided within the craft room (classroom). The sink is currently at 36" and does not provide a forward approach (roll-under). The towel and soap dispensers are currently mounted above the maximum reach.

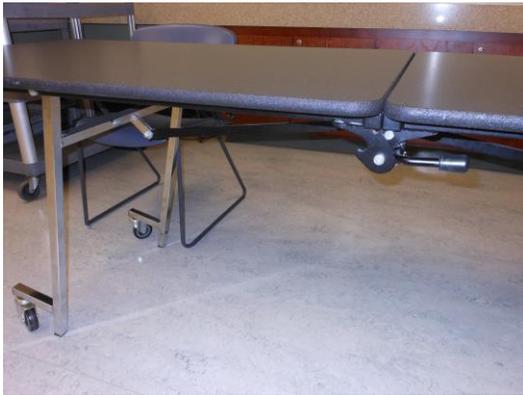
Photo 7: Movable folding tables are provided in the dining room (also used for bingo and other activities). The structural supports for the table currently obstruct the knee and toe clearance needed for a forward approach.

25E.1 20327	Provide a table with a forward approach including knee and toe clearance below- 30" wide minimum, 27" high knee clearance and 9" high toe clearance that extends 17"-25". ADA 902 <i>Movable tables are provided in the dining room. The structural supports currently obstruct the knee and toe clearance.</i>	1	\$200	\$200	3				
				<i>Location Subtotal:</i>					\$2,200
Dining Room- Drinking Fountains									
41F 20325	Reposition the drinking fountain or add a guard to eliminate the protruding hazard. ADA 307 <i>The drinking fountains currently protrude at a height of 32 3/4". Photo 8.</i>	1	\$200	\$200	3

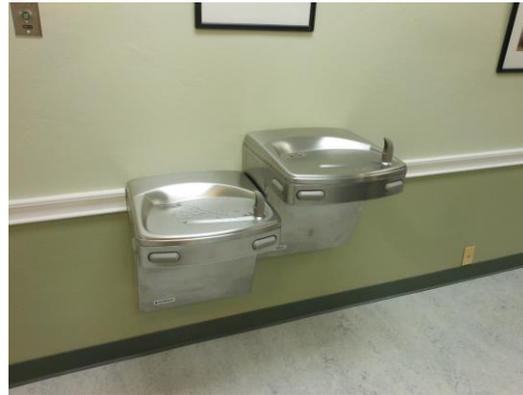
Photo 8: Dual height (accessible and standing height) drinking fountains are provided in the dining room. *This is a good example of accessibility.* Currently the drinking fountains protrude into the circulation route.

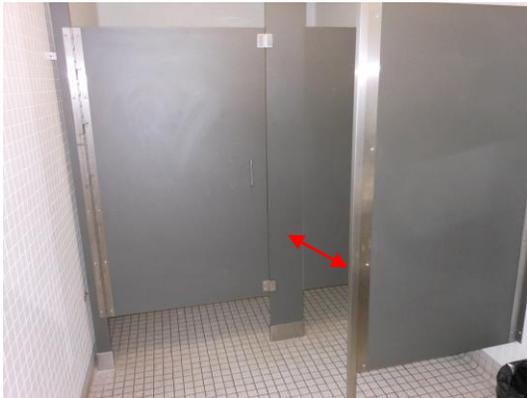
Photo 10: In the men's toilet room the privacy screen for the urinal currently obstructs the maneuvering clearance on the pull side of the accessible stall door.

Location JQP # / Item #	Solution / Comments	Qty	Unit Cost	Total Cost	Priority	Estimated Compl. Date	Person Responsible	Actual Compl. Date	Actual Cost
Men's Toilet Room									
221	20326	Re-hinge the stall door at the accessible stall in order to provide maneuvering clearance at the stall door. ADA 604.8.1.2, 404.2.4 <i>The door to the accessible toilet stall currently swings "out" of the stall- it does not currently provide maneuvering clearance on the pull side of the partition door. The maneuvering clearance is obstructed by the privacy partition for the urinal. Due to the power door opener at the entry door- the privacy screen at the urinal is necessary. Swinging the stall door "in" would not provide adequate maneuvering clearance from within the toilet stall (although a 30" x 48" clear floor space would still be provided beyond the arc of the door swing). No action is recommended at this time; as an alteration to an existing facility it was likely not technically feasible to provide a fully compliant toilet stall. Photo 10.</i>	1	\$75	\$75	4

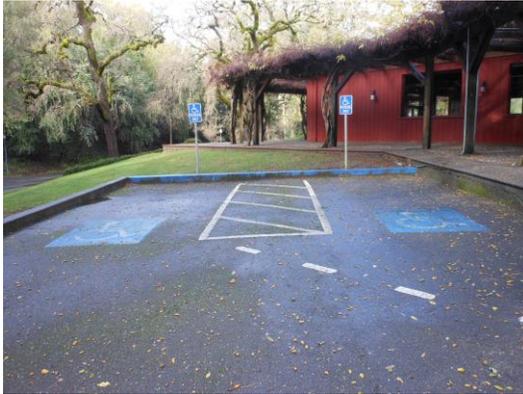
Photo 1: There are 2 parking spaces to the west of the Villa entry. Currently the slope within the parking spaces is up to 3.1% (vs. 2% maximum).

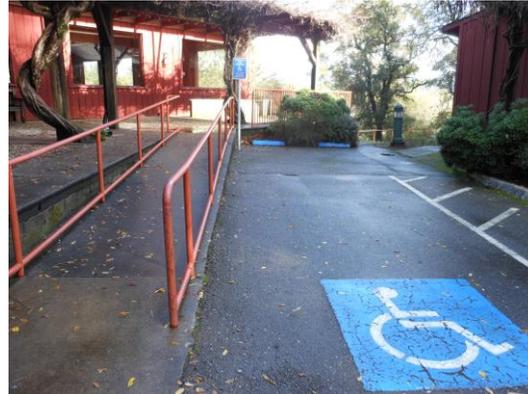
Photo 2: There is 1 space designated as accessible adjacent to the ramp. The space has a sign indicating "Vans with Automatics Ramps Only". Currently the aisle is 4'-3" wide (vs. 5' wide minimum for an accessible space and 8' wide minimum for a van accessible space).
