*Accessibility Evaluation
for*

**City of Healdsburg, CA
Community Services and
Parks & Recreation Department**

2017

julee quarve-peterson, inc.

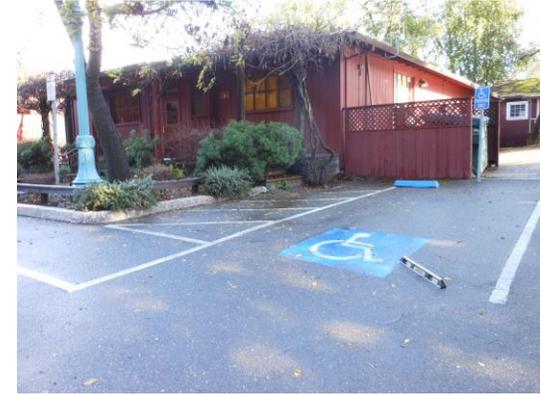
Photo 3: There is 1 space designated as accessible to the west of the annex. Currently the slope within the parking space is up to 9.9% (vs. 2% maximum).

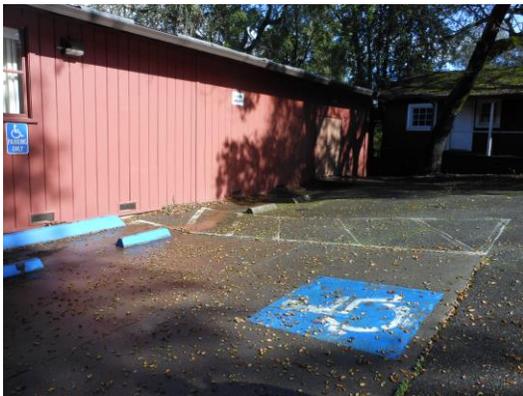
Photo 4: There is 1 parking space designated as accessible to the south of the annex. Currently the slope within the parking space is up to 12.1% (vs. 2% maximum).

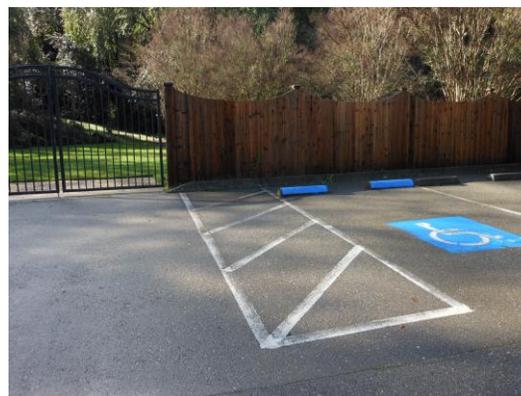
Photo 5: There is 1 parking space designated as accessible near the upper garden. Currently the slope within the parking space is up to 3.2% (vs. 2% maximum). An upright sign is not currently provided at the parking space.

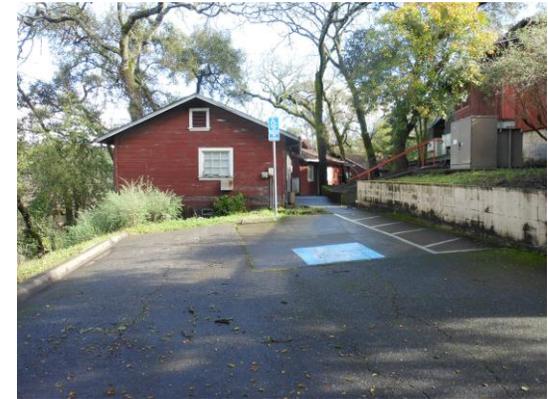
Photo 6: There is 1 parking space designated as accessible near the loading dock to the north of the villa. The sign indicates it is "van" accessible. Currently the aisle is 4'-5" wide (vs. 5' wide minimum for an accessible space and 8' wide minimum for a van accessible space).

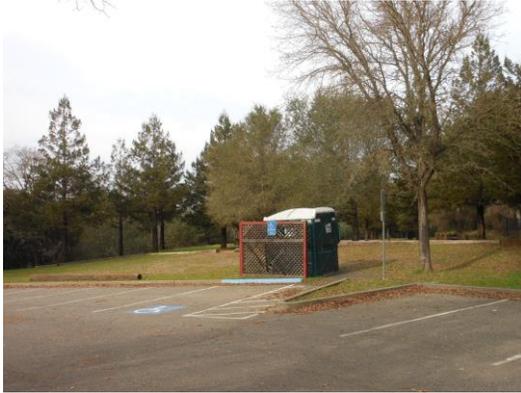
Photo 7: There is 1 parking space designated as accessible near the playground. Currently the slope within the parking space is up to 3.8% (vs. 2% maximum). There is not currently an accessible route from the parking space to the play area.

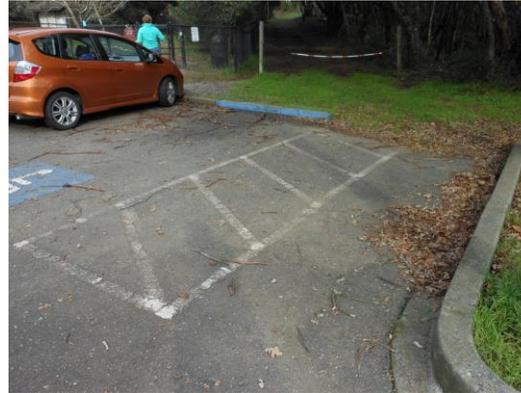
Photo 8: There is 1 parking space designated as accessible near the dog park. There is not currently a sign designating the accessible parking space.

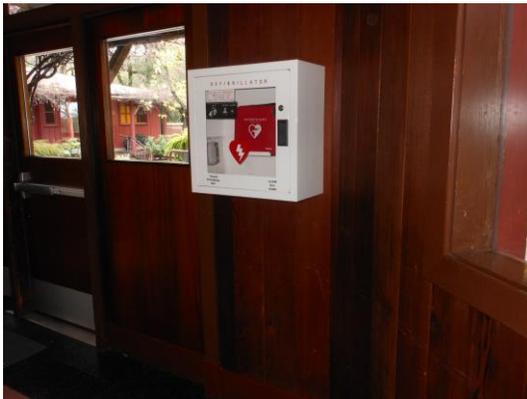
Photo 10: An automated external defibrillator (AED) is provided in the lobby. The door to case is currently at 54" (vs. 48" maximum).

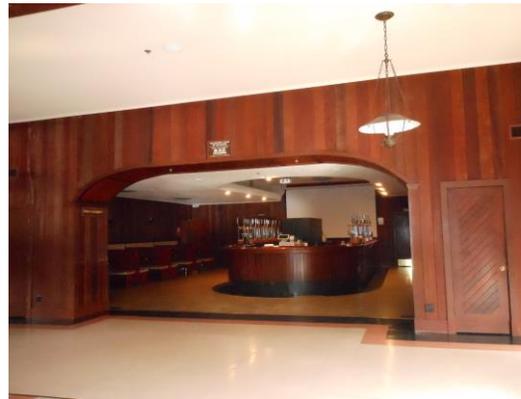
Photo 11: A bar is provided between the 2 banquet rooms. The bar includes bar seating and booth seating. There are currently no accessible seating positions provided. The bar is at 43" AFF (vs. 34" maximum).

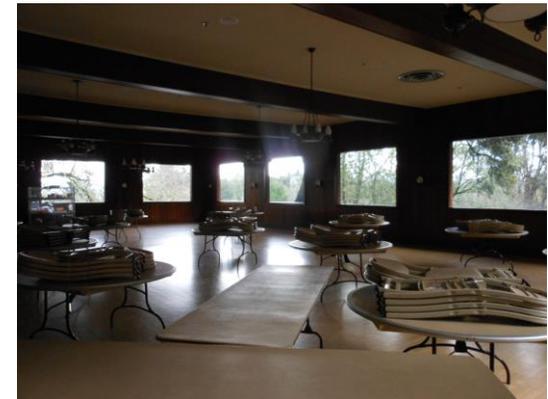
Photo 12: There are 2 banquet rooms available. Both rooms provide an audio amplification system. Ensure an assistive listening system is provided.

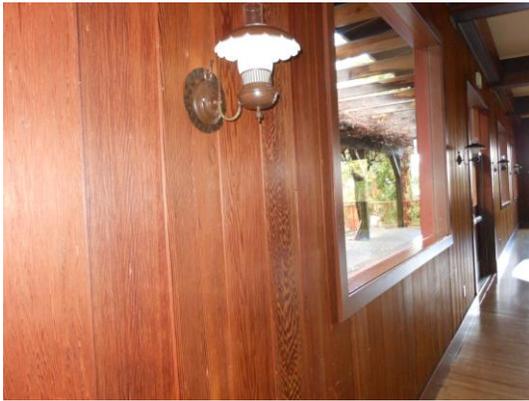
Photo 13: The wall sconces in the banquet rooms currently protrude 5 ½" at a height of 70" into the circulation route.

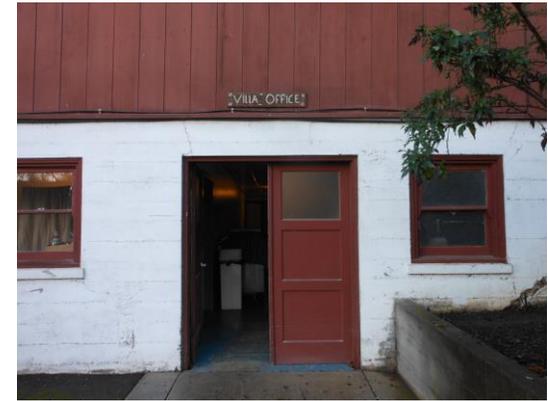
Photo 15: The lower level of the villa includes toilet rooms, storage and office space. There is not an interior route between the main and lower levels; there are only exterior stairs.

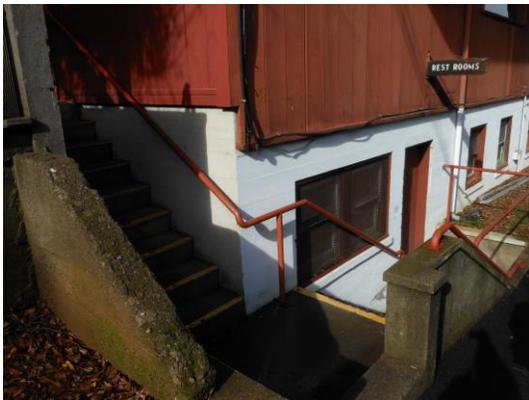
Photo 16: There are exterior stairs leading to the public toilet rooms in the lower level of the villa. Note: at the time of site visit the toilet rooms were locked and no longer available to the public (portable toilet facilities were provided near the playground).

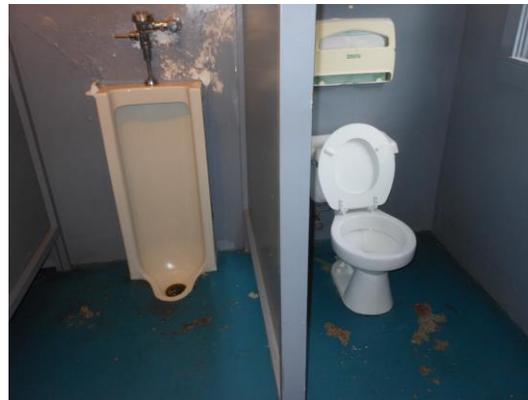
Photo 17: There are currently no features of accessibility provided in the lower level toilet rooms.

Location JQP # / Item #	Solution / Comments	Qty	Unit Cost	Total Cost	Priority	Estimated Compl. Date	Person Responsible	Actual Compl. Date	Actual Cost
Women's Toilet Room- Lower Level									
22.1 20288	Upgrade toilet room to be fully accessible. The existing toilet room is large enough to provide compliant clearances, but does not currently provide any compliant features of accessibility. ADA 213.2, 603 <i>There are currently no features of accessibility provided in this toilet room and it is not located on an accessible route.</i>	1	\$10,000	\$10,000	4				
				Priority # 4 Total	\$276,825

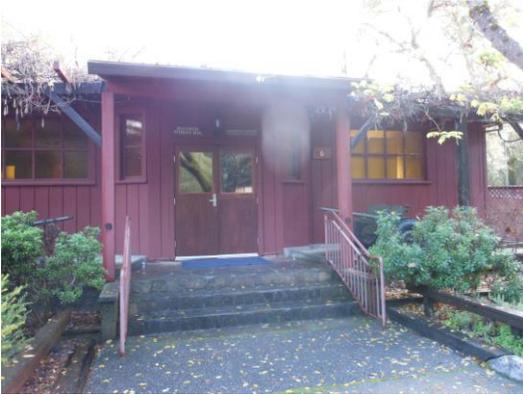
Photo 1: View of entry to the Villa Annex. There is not currently an accessible route to the main entry (exterior steps). Add a sign directing to the side entry until such time an accessible route is provided to the main entry.

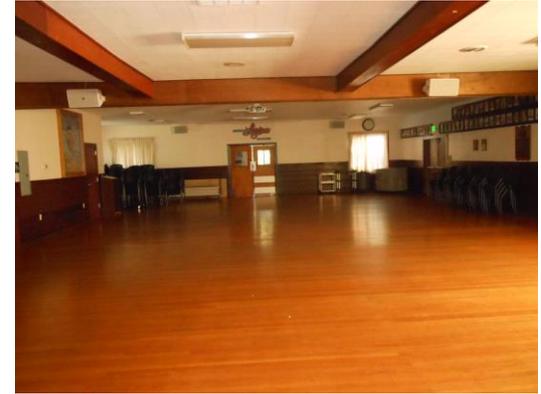
Photo 3: View of the Annex interior. An audio amplification system is currently provided for the open space. Ensure an assistive listening system is provided.

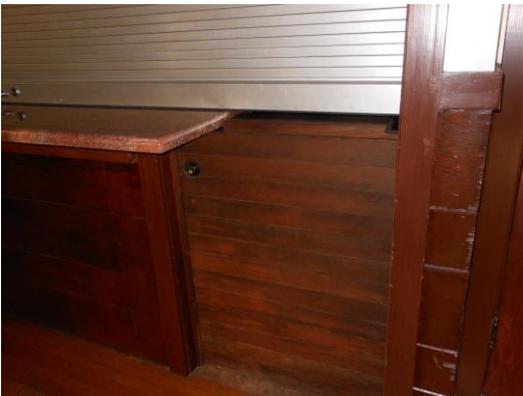
Photo 4: The service counter is currently at 44" AFF (vs. 34" maximum). In addition the route to the employee side of the counter currently has a 23" clear opening (vs. 32" minimum). Verify if the service counter is still used.

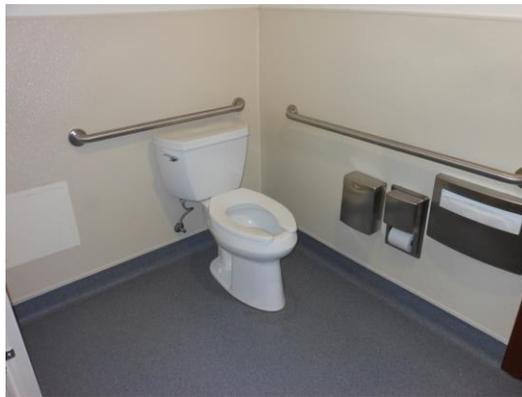
Photo 5: Modifications have been made to the men's and women's toilet rooms to provide features of accessibility. *This is a good example of accessibility.*
